Update to WSCAC on  
Sudbury Spillway Masonry/  
Gatehouse Vent Repair  
and  
North Dike Overtopping Protections

12.11.24

# CIP: Sudbury Dam Spillway Masonry Repair and GH Vent Pipe

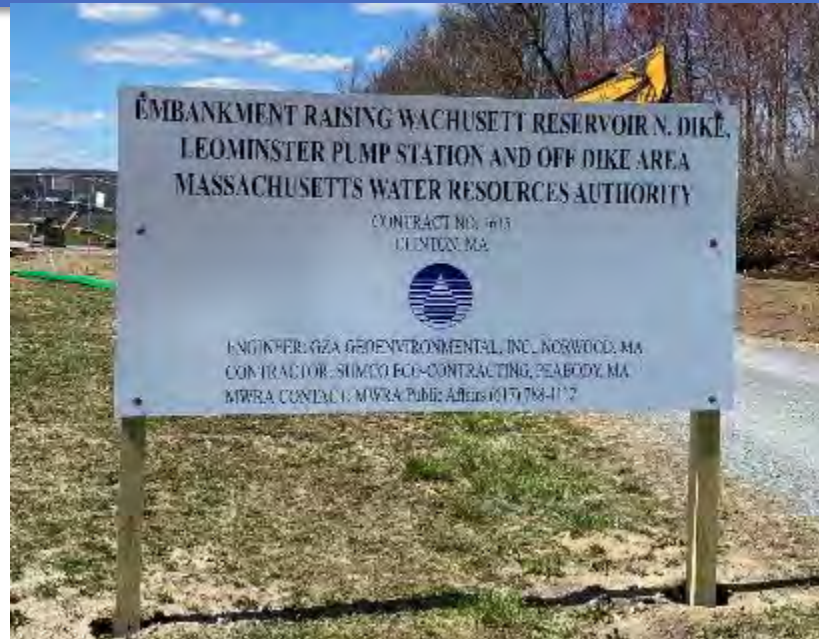
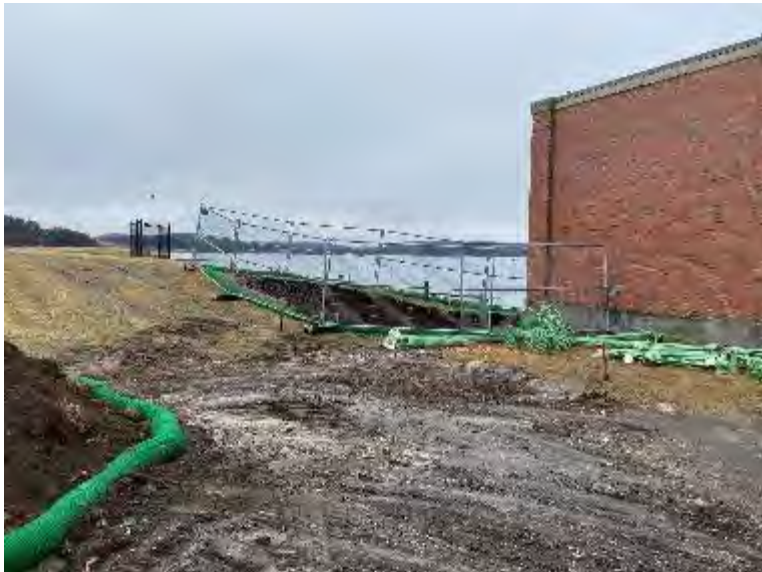
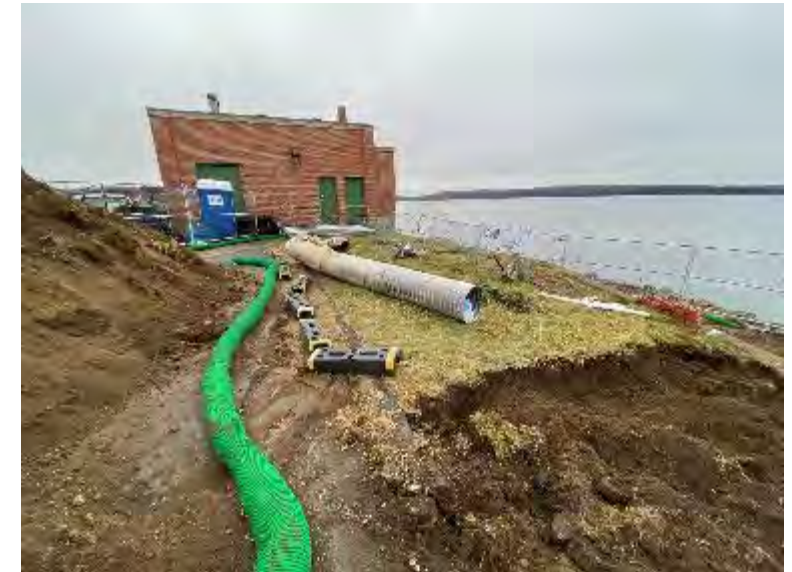
# 03.27.24 Removal of abandoned CMP

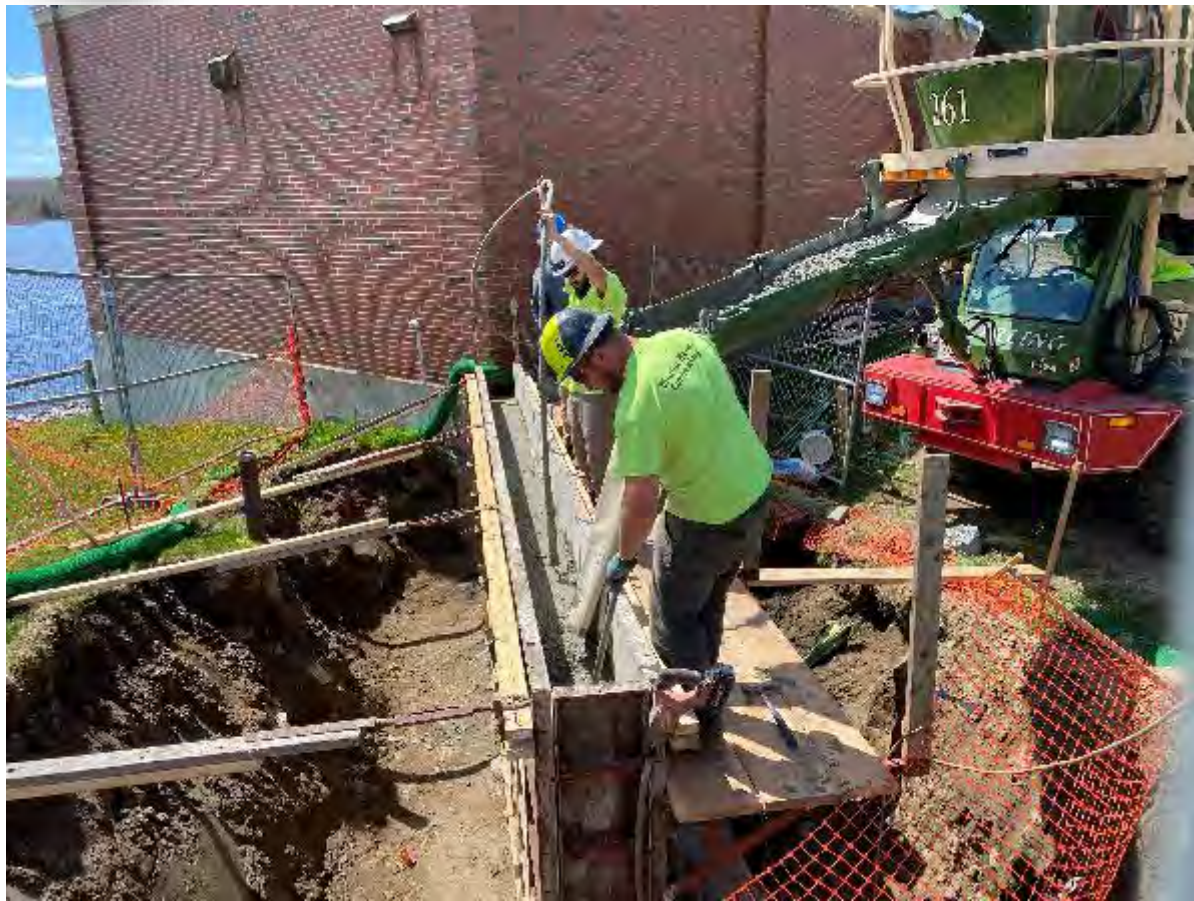
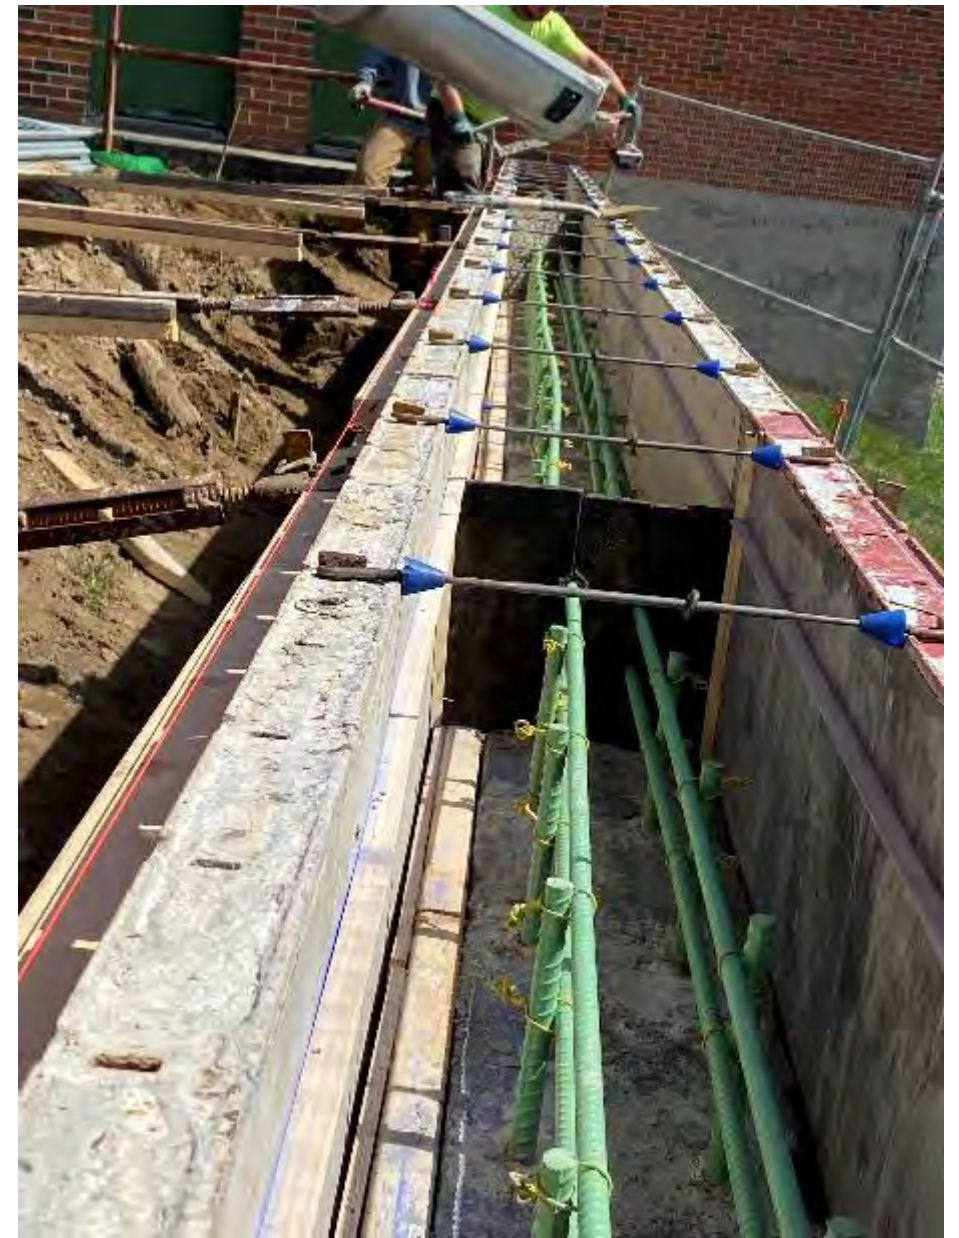
# Before and After

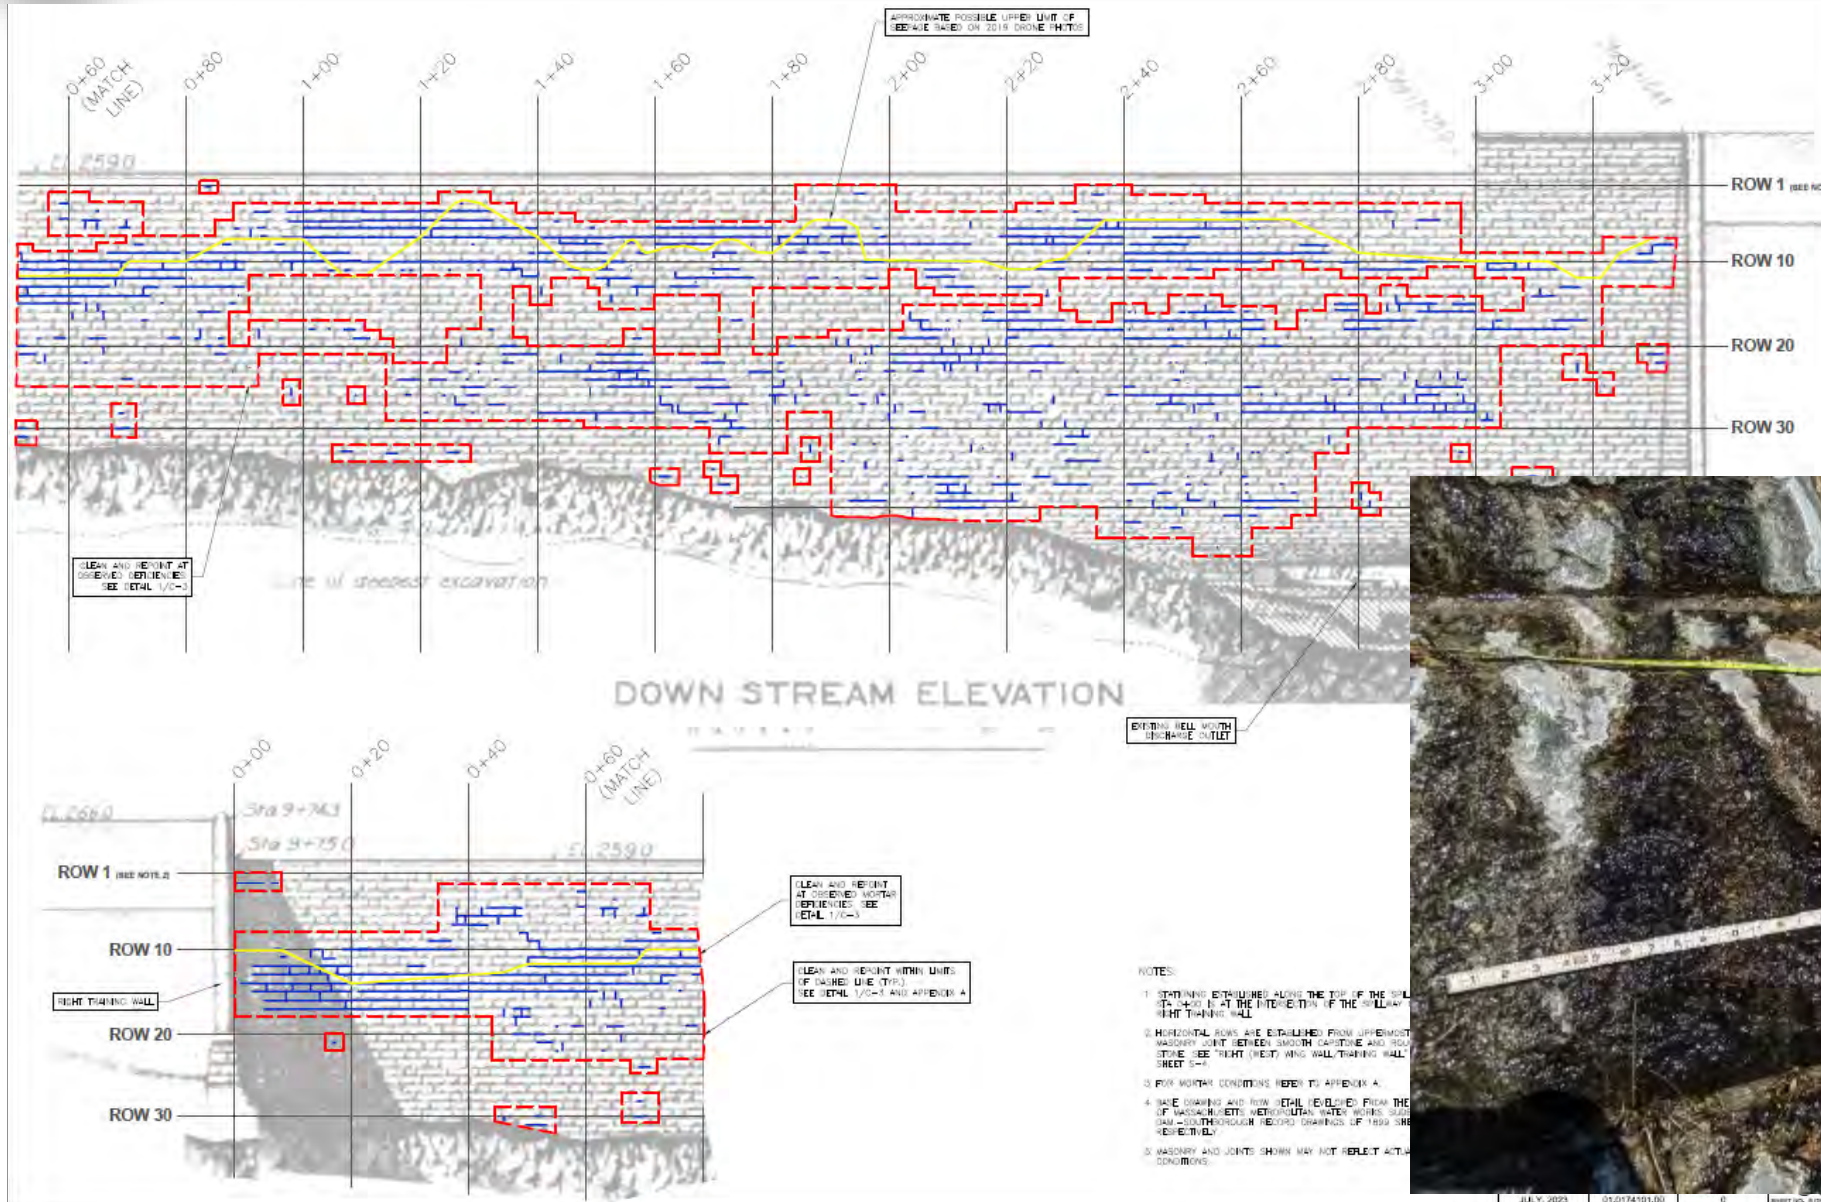
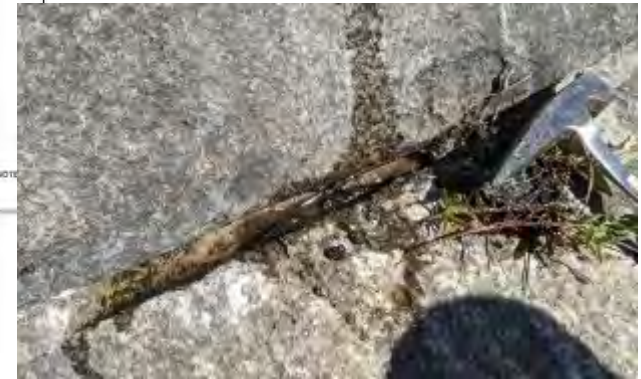
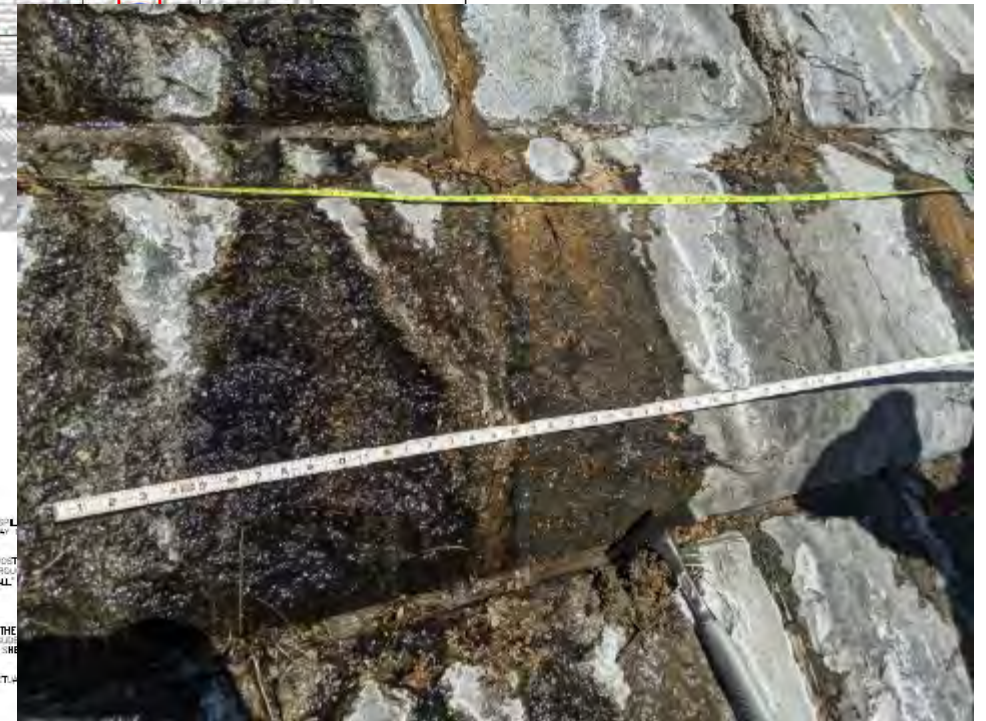
# Spillway Face mortar deficiencies and repair

- Clean masonry and remove vegetation and efflorescence.
- Repair of mortar on the Sudbury Dam spillway and GH. Restore weepholes.
- Abandon 2 obsolete piezometers
- Repair of the Sudbury Dam gatehouse vent pipe
- Cost for engineering design: \$87,151
- Cost for ESDC: \$36,140
- Construction: \$1,600,000

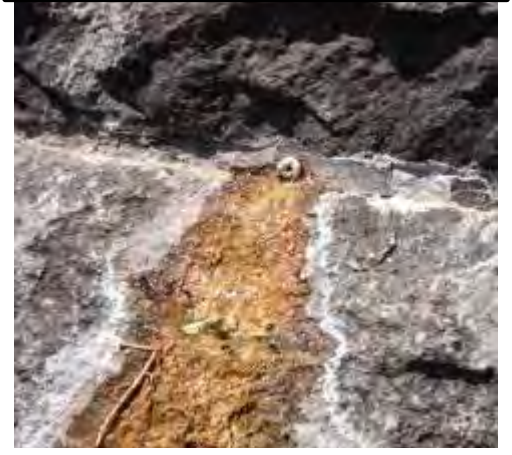
Before weep hole cleaning

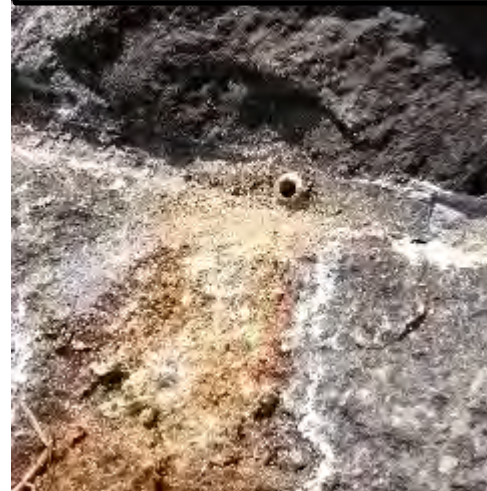
After weep hole cleaning

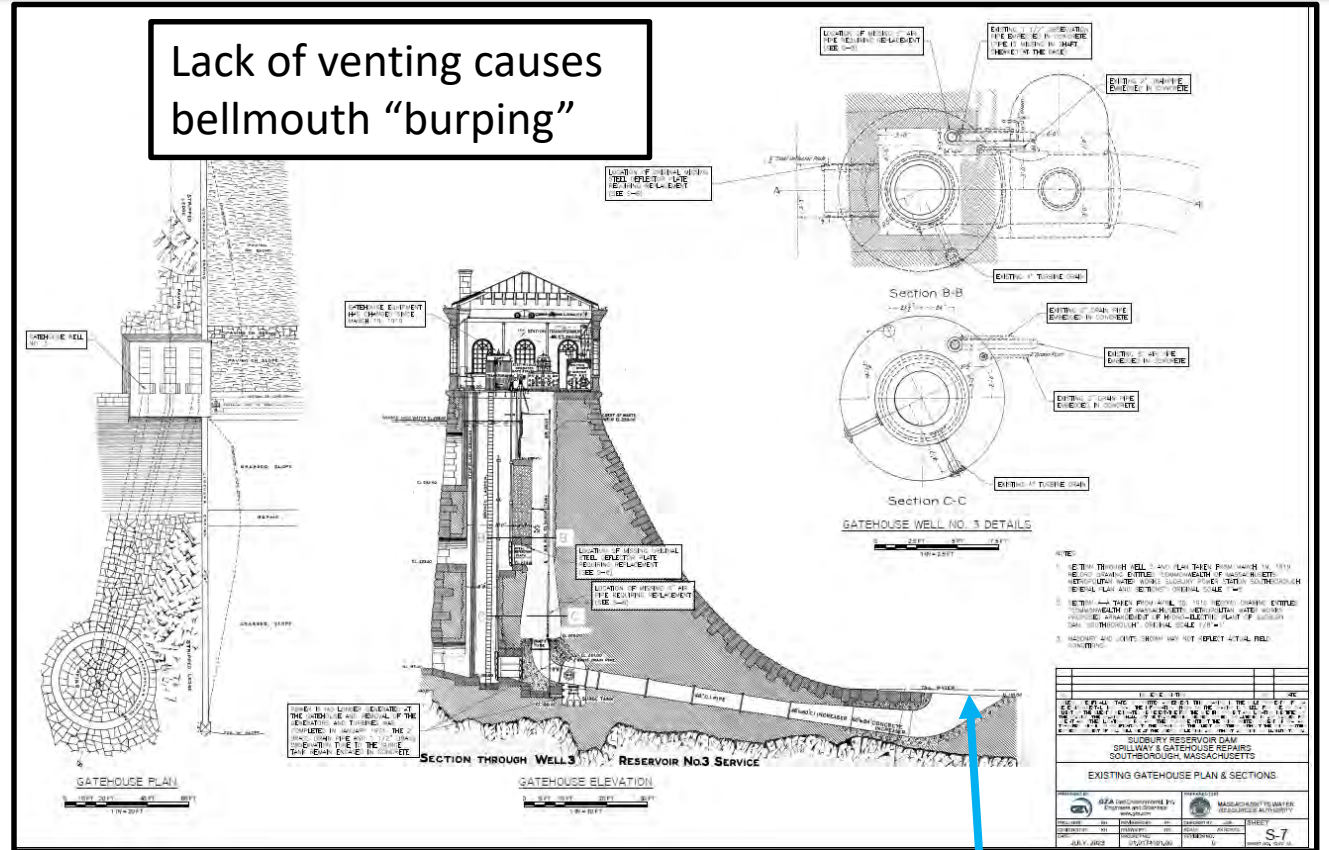
Lack of venting causes bellmouth "burping"

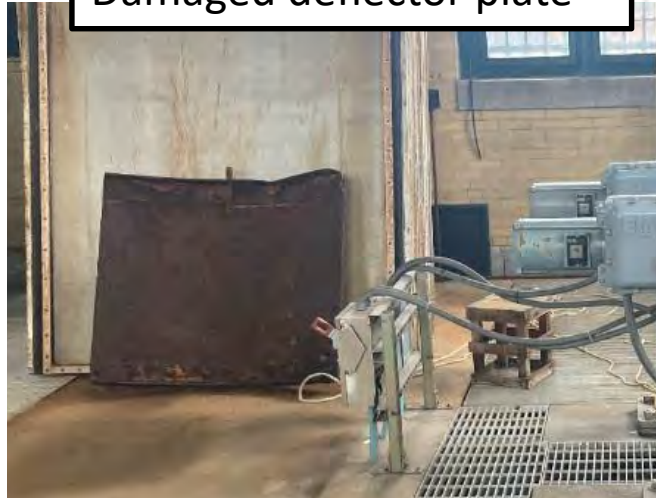
Damaged deflector plate
