2011 Outfall Monitoring Overview

Environmental Quality Department Report 2012-11

Massachusetts Water Resources Authority

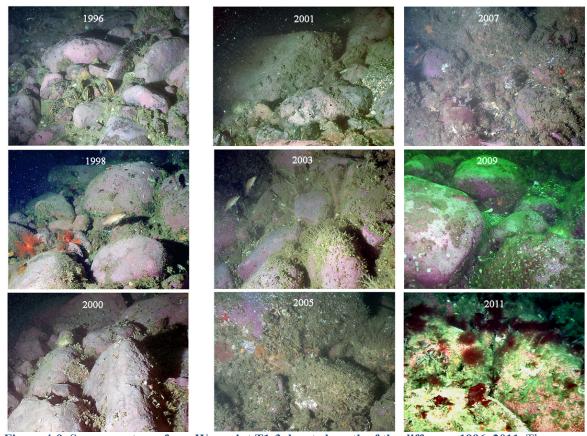
Figure 4-9. Screen captures from Waypoint T1-3, located north of the diffusers, 1996–2011. The photographs in the left-most column are from baseline years, and the photographs on the right are from 2001–2011, the period since the outfall came on line.

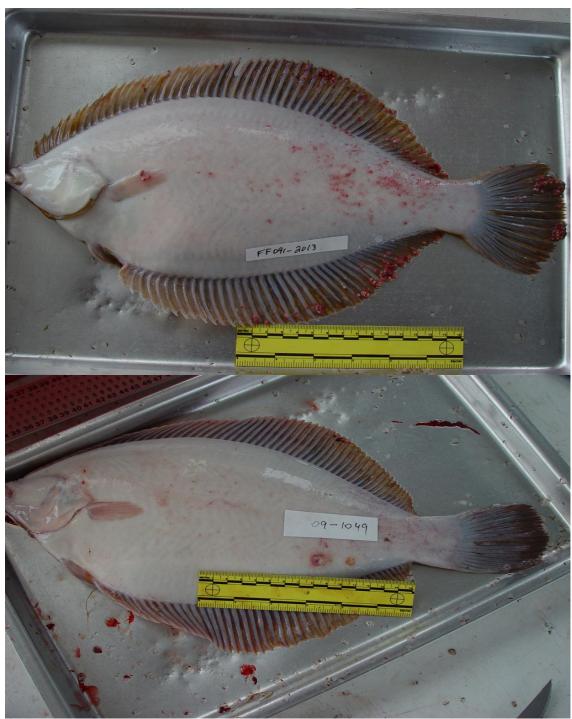
Figure 5-2. External conditions noted during the 2011 field program. Top: External blind-side hemorrhage resulting from net trauma. Bottom: Blind-side ulcers.
