2017 Outfall Monitoring Overview

Massachusetts Water
Resources Authority
Environmental Quality
Department Report 2018-07

Werme C, Keay KE, Libby PS, Codiga DL, Taylor DI, Charlestra L, Carroll SR. 2018. 2017 outfall monitoring overview. Boston: Massachusetts Water Resources Authority. Report 2018-07. 53 p.

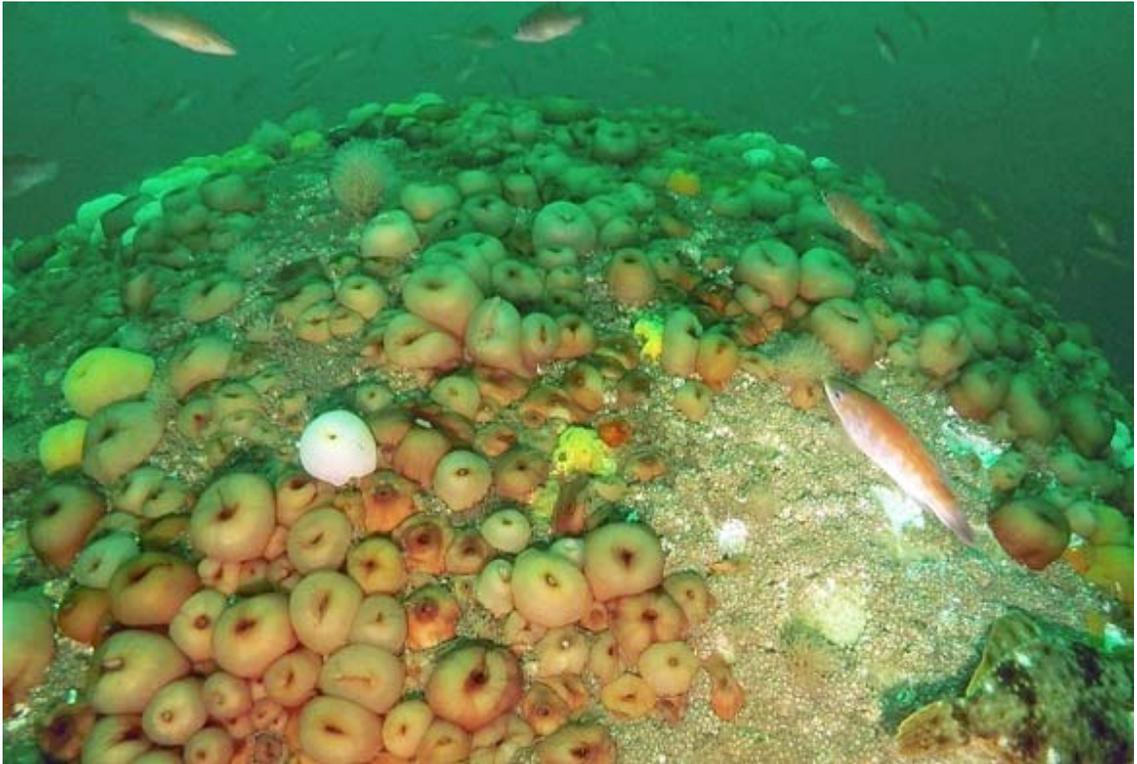
Figure iii. Lush growth of sea anemones and barnacles on an active diffuser head in 2017. Photo credit Barbara Hecker/Normandeau Associates.

Healthy benthic communities continue to thrive on the Massachusetts Bay sea floor, where habitats continue to be controlled more by physical factors, such as storm-induced waves and currents, than by outfall discharges. Lush communities of sea anemones and barnacles cover the active outfall diffusers, which are also frequented by fish (Figure iii).

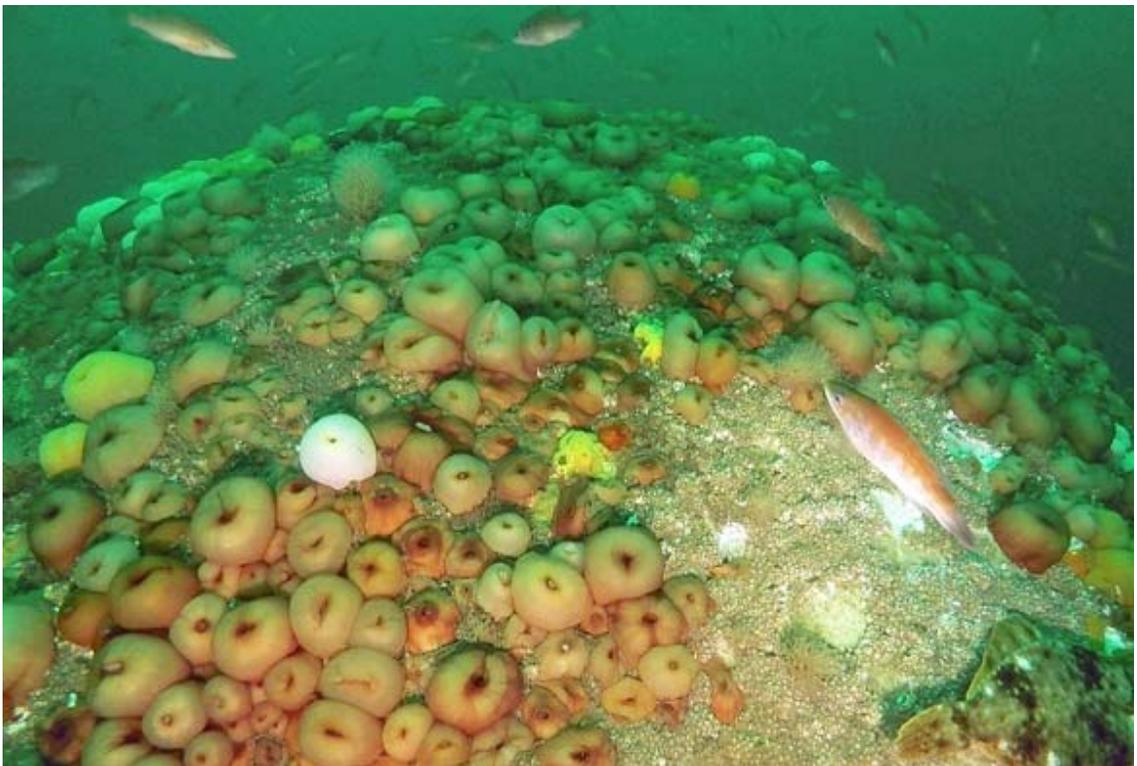
Figure 4-10. Lush growth of sea anemones and barnacles on an active diffuser head in 2017.
Photo credit Barbara Hecker/Normandeau Associates.

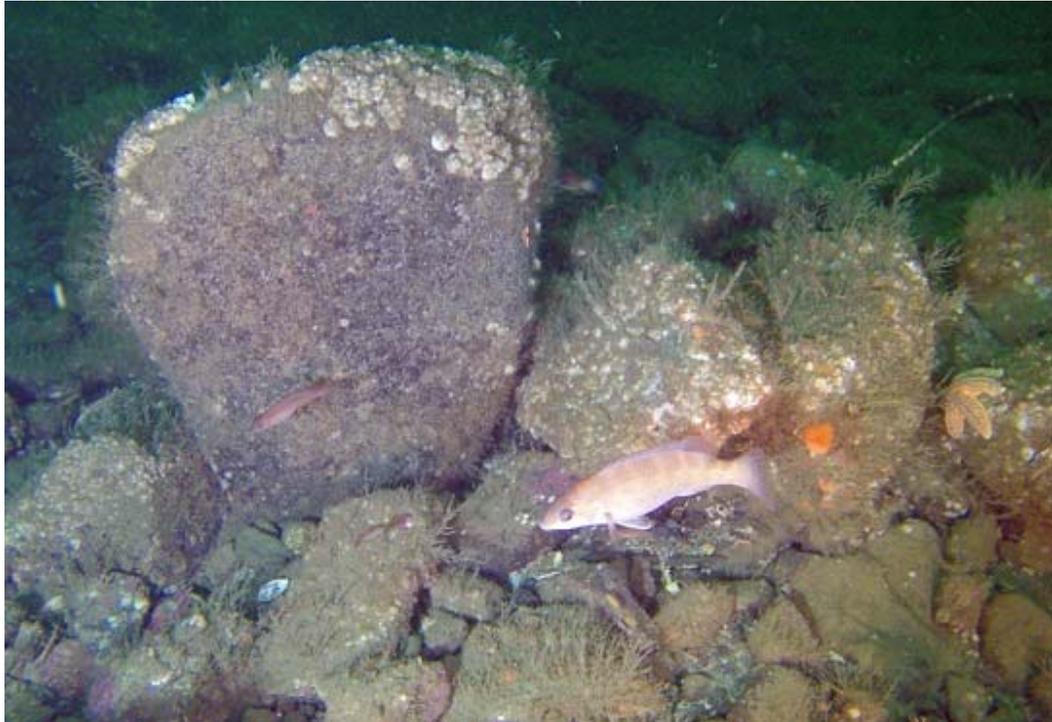
Figure 4-11. Overturned boulder at a northern reference station, where deep-draft tankers have been observed to anchor. Photo credit Barbara Hecker/Normandeau Associates.

Since 2007, the hard-bottom surveys have documented severe disturbance caused by deep-draft tankers anchoring at the northern reference site, Station T7-1, and evidence of disturbance was found again in 2017 (Figure 4-11). The disturbance includes overturned boulders and anchor scars.

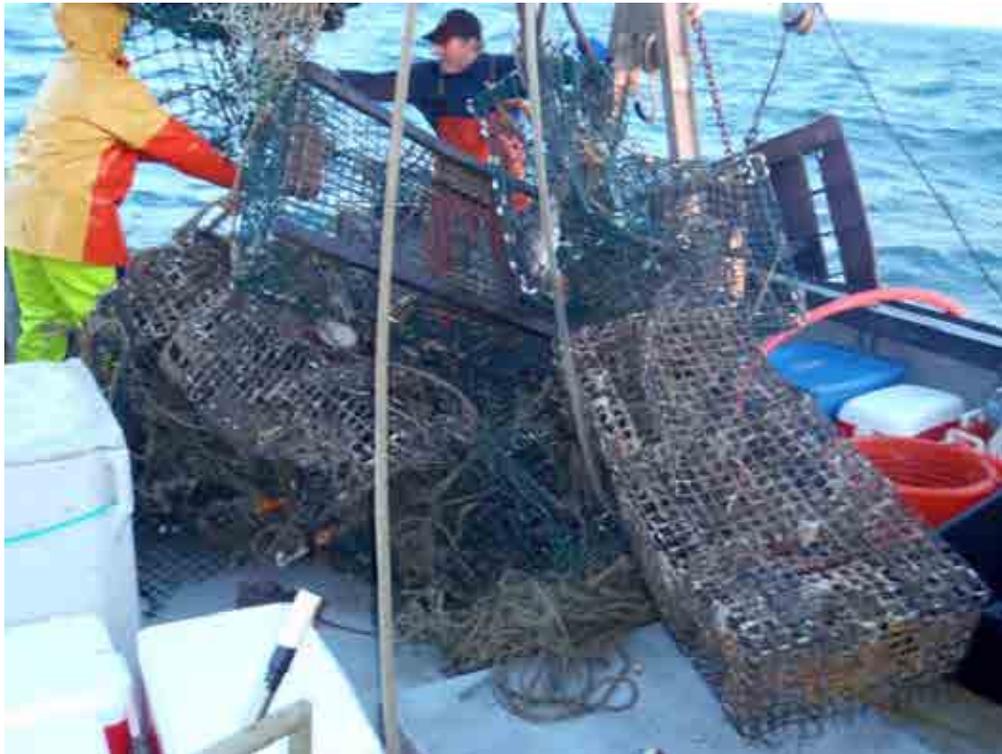
Figure 5-2. “Ghost” lobstering gear brought up in MWRA flounder trawls can make collection difficult, especially at Deer Island Flats and near the outfall site.

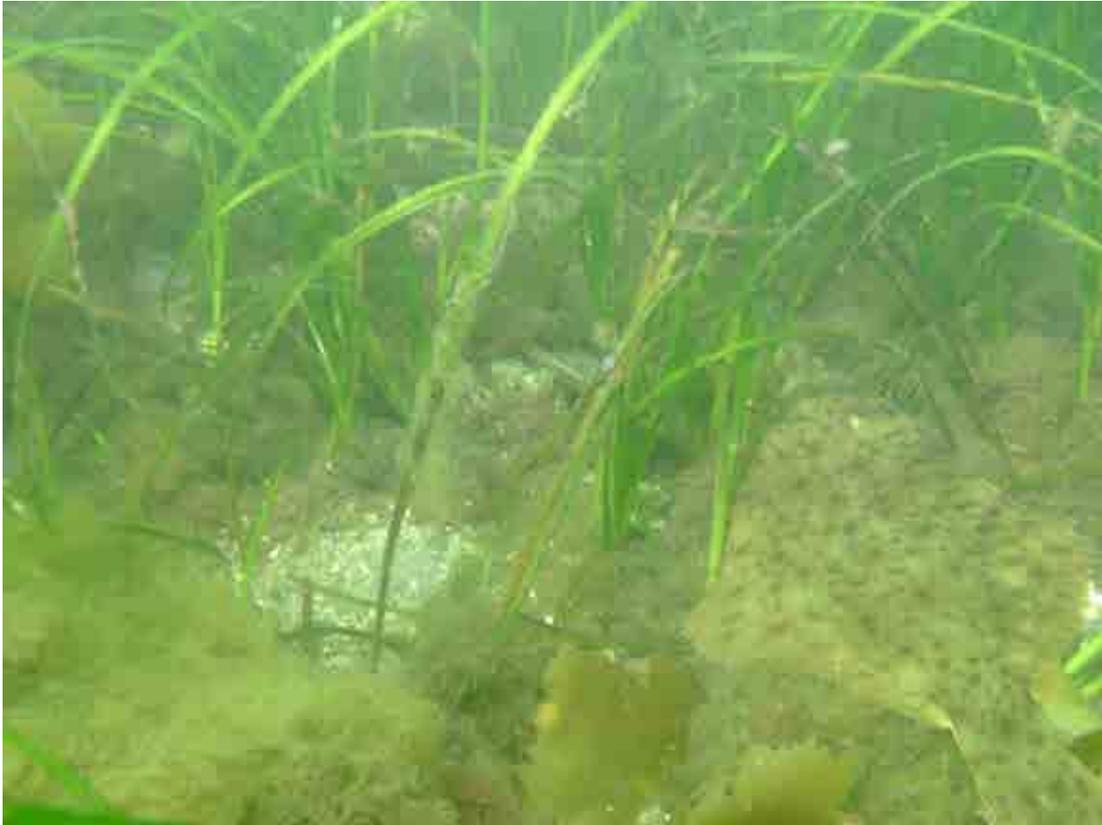
Figure 6-6. Eelgrass in Boston Harbor is thriving in areas where it was not previously seen, providing habitat for flounder and other fish and shellfish. Photo credit Phil Colarusso, EPA.

Another indication of decreased eutrophication and habitat enrichment, eelgrass beds, which provide a healthy habitat for fish and shellfish, have begun to grow in parts of Boston Harbor where seagrasses had not previously been seen (Figure 6-6). No concurrent habitat degradation has occurred in Massachusetts Bay, where monitoring has shown that physical processes, such as storms and storm-induced sediment transport, are the primary stressors on the environment. Bottom-dwelling animal communities have remained healthy and diverse, with no indication of eutrophic effects.
