# 2018 Outfall Monitoring Overview

Massachusetts Water  
Resources Authority  
Environmental Quality  
Department Report 2019-07

Werme C, Keay KE, Libby PS, Codiga DL, Charlestra L, Carroll SR. 2019. 2018 outfall monitoring overview. Boston: Massachusetts Water Resources Authority. Report 2019-07. 53 p.

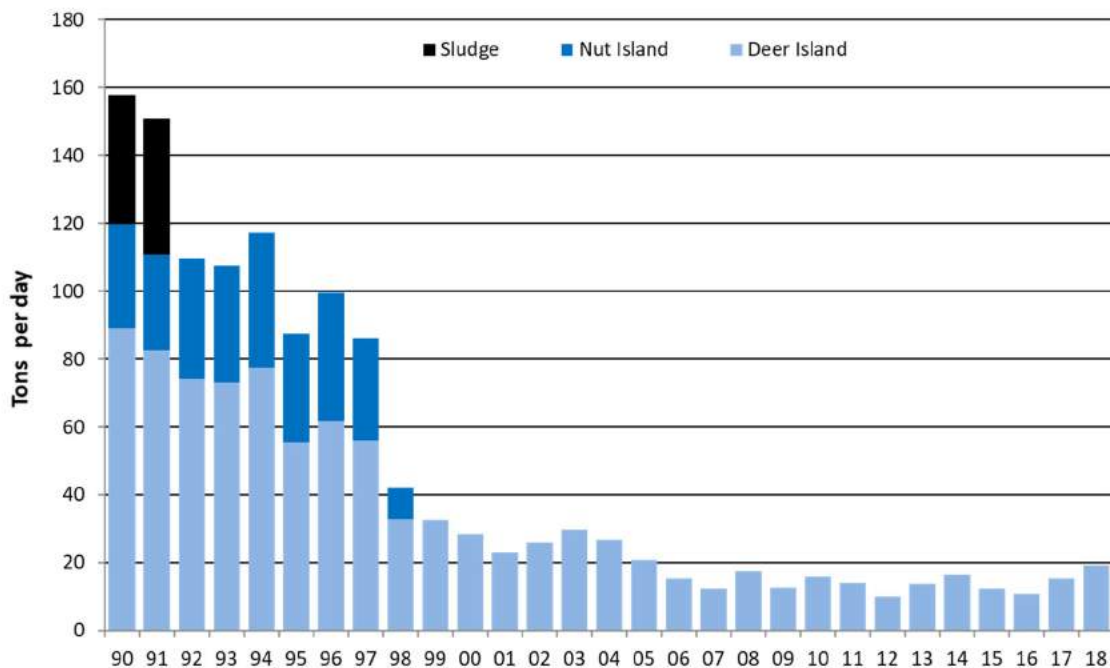
**Figure i. Annual solids discharges, 1990–2018.** Before December 1991, biosolids (sludge) removed during treatment were digested anaerobically and discharged into Boston Harbor. Ending biosolids disposal, ending effluent discharge to the southern portion of the harbor from Nut Island, implementing secondary treatment, and culminating in ending all discharges to the harbor in September 2000 were important steps for the Boston Harbor Project. Since 2006, variability in solids discharges to Massachusetts Bay can be attributed mostly to variation in effluent flow.

Through 2018, Deer Island Treatment Plant continued to operate as designed, earning MWRA the National Association of Clean Water Agencies Platinum 12 Peak Performance Award for facilities with 100% compliance with permit conditions over twelve consecutive years. Solids discharges, the portion of the municipal effluent that contains most of the persistent organic and inorganic contaminants, remained low, only a fraction of the discharges that had been made to Boston Harbor in the 1990s (Figure i).

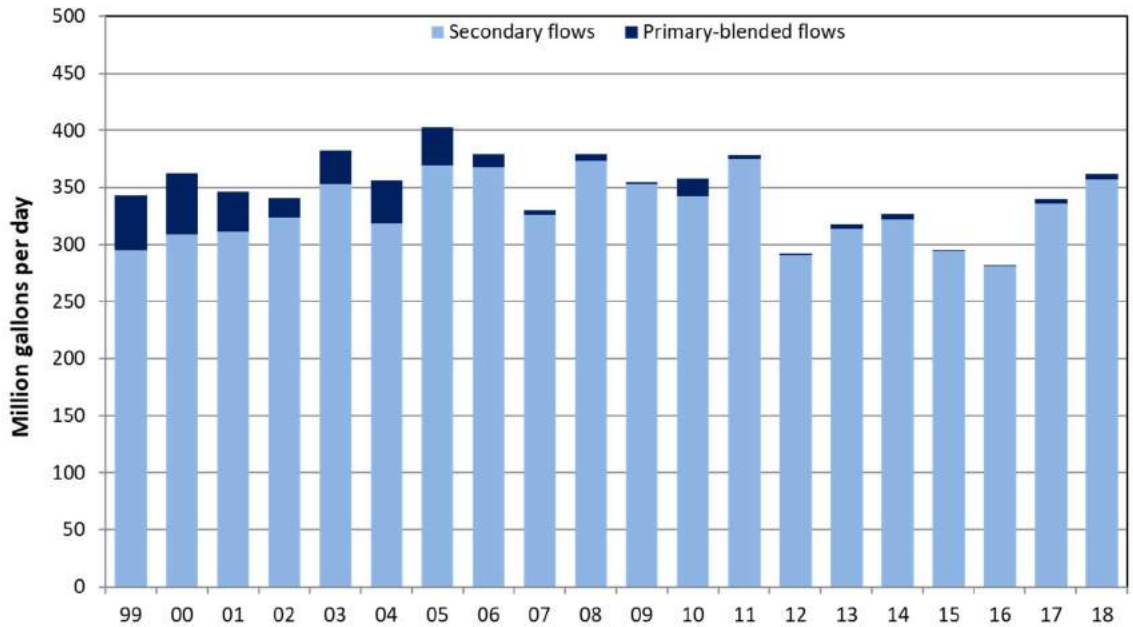
**Figure 2-2. Annual full secondary and primary-blended effluent flows, 1999–2018.** During some large storms, flow exceeding the secondary capacity of the plant is diverted around the secondary process. Primary-treated flows are blended into secondary-treated effluent and disinfected before discharge.

Corresponding to the higher rainfall, effluent flow in 2018 was 357 million gallons per day (MGD), slightly higher than flow in 2012–2017 and higher than the longer-term 1999–2018 average of 330 MGD (Figure 2-2). Almost all the flow, 99%, received full primary and secondary treatment, with only trace discharges of primary-treated effluent blended with fully treated effluent prior to discharge in any month (Figure 2-3).

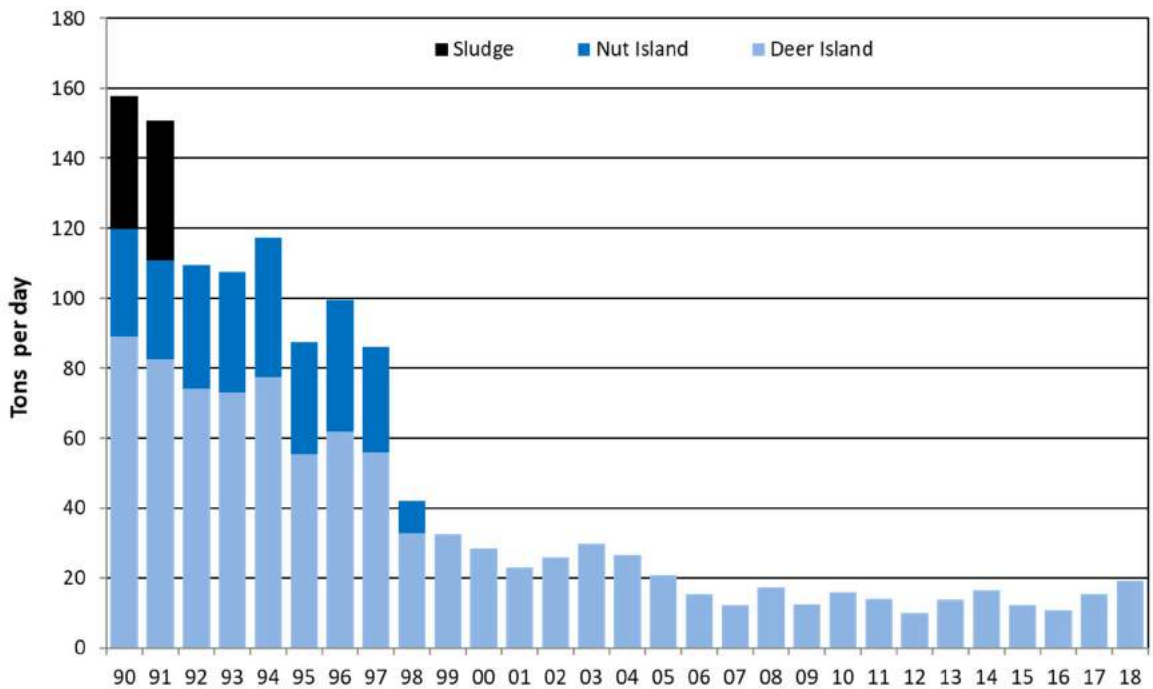
**Figure 2-4. Annual solids discharges, 1990–2018.** Before December 1991, biosolids (sludge) removed during treatment were digested anaerobically and discharged into Boston Harbor. Ending biosolids disposal, ending effluent discharge to the southern portion of the harbor from Nut Island, implementing secondary treatment, and culminating in ending all discharges to the harbor in September 2000 were important steps in the Boston Harbor Project.

The total suspended solids load to Massachusetts Bay, about 19 tons per day, was higher than in recent years, but below levels measured before 2005 and far below the levels discharged into Boston Harbor before the outfall diversion in 2000 (Figure 2-4). In recent years, variability in the suspended solids load has corresponded to variability in rainfall and effluent flow (Figure 2-5). For example, 2015 and 2016 were drought years, with correspondingly low flows and extremely low solids loading compared to 2018, which was rainier and had higher loading. Carbonaceous biochemical oxygen demand, a measure of the amount of oxygen consumed by microorganisms, also remained low, well below levels that would be expected to affect dissolved oxygen concentrations at the discharge (not shown).

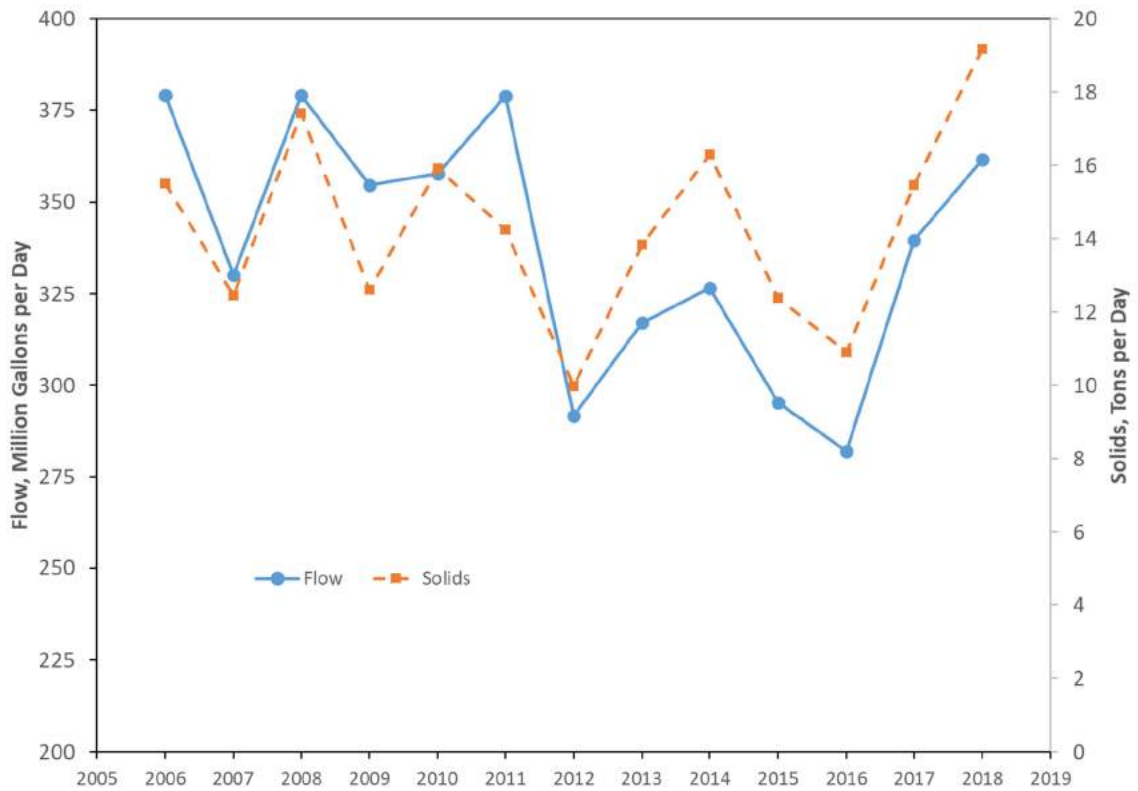
**Figure 2-5. Annual solids discharges and flows, 2006–2018.** Since 2006, variability in solids discharges to Massachusetts Bay can be attributed mostly to variation in effluent flow.

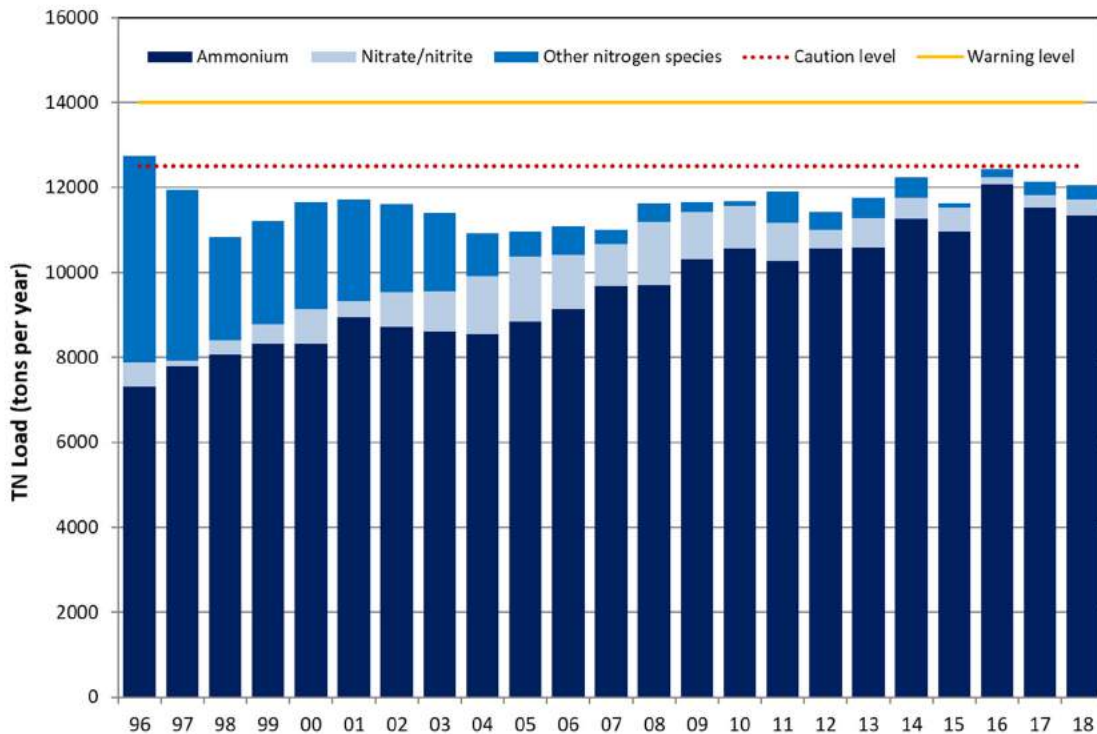
**Figure 2-6. Annual nitrogen discharges, 1996–2018.** The caution threshold is set at 90% of the warning level, which was the anticipated discharge for the year 2020, 14,000 tons per year.

Despite the increased flow, the total nitrogen load was lower than in recent years, remaining just under its Contingency Plan caution-level threshold (Figure 2-6) and well below the warning-level threshold, 14,000 metric tons per year. The caution level was somewhat arbitrarily set as 90% of the warning level; the warning level was the anticipated total nitrogen load for the year 2020, projected during design of the treatment plant. Since 2000, when discharges to the harbor ended, total nitrogen loads have been lower than were predicted at the start of the Boston Harbor Project.

Total effluent nitrogen loads reflect variability in nitrogen levels in the influent reaching Deer Island, with about 30% of the nitrogen removed during treatment. Total nitrogen loads have increased modestly since the Massachusetts Bay outfall began to discharge, most likely due to population increases in the MWRA service area. There have been no observed unexpected or adverse environmental effects due to nitrogen discharge into Massachusetts Bay, and water-quality modeling has suggested that even large increases to the nitrogen discharge would have no adverse effect on the environment. The portion of the nitrogen load made up of ammonium declined for a second year after a record high in 2016. Increased ammonium loads are a consequence of the biological treatment process and addition of ammonium-rich liquids from the biosolids pelletizing plant, which converts biosolids to fertilizer.

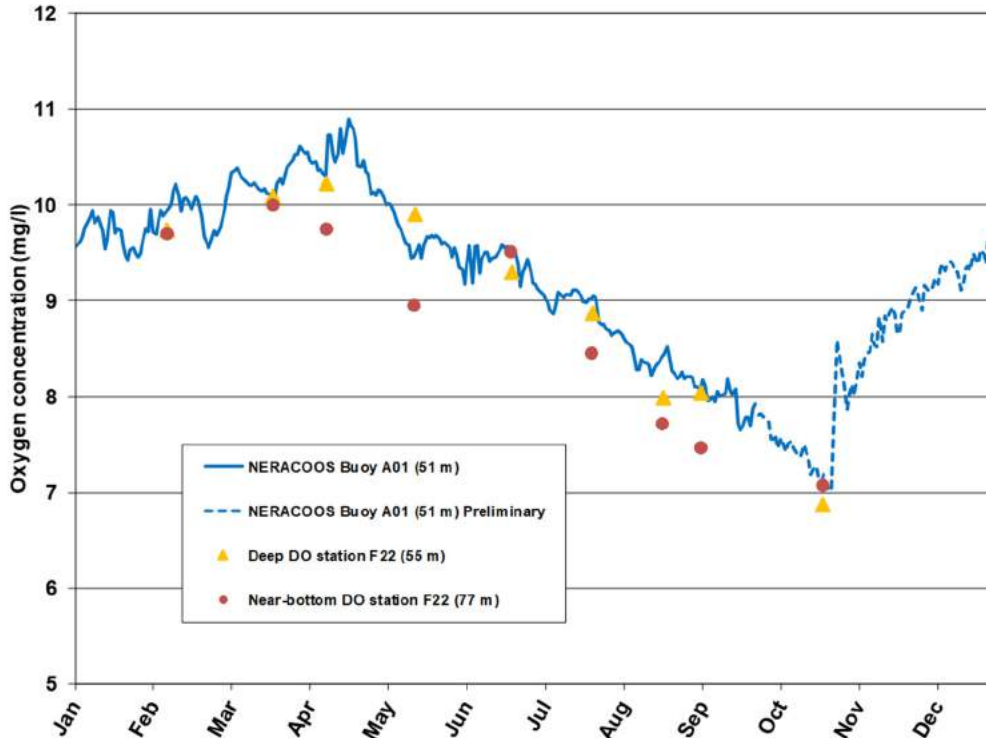
Figure 3-14. Dissolved oxygen at Buoy A01 and at Station F22 in Stellwagen Basin. NERACOOS = Northeastern Regional Association of Coastal and Ocean Observing Systems DO = dissolved oxygen

Deep and near-bottom dissolved oxygen concentrations at Station F22 in Stellwagen Basin were healthy throughout 2018. Both survey observations and data from Buoy A01, located within the sanctuary, showed the typical decline during the stratified season (Figure 3-14). Data from the buoy documented the return to oxygenated conditions following fall mixing events.

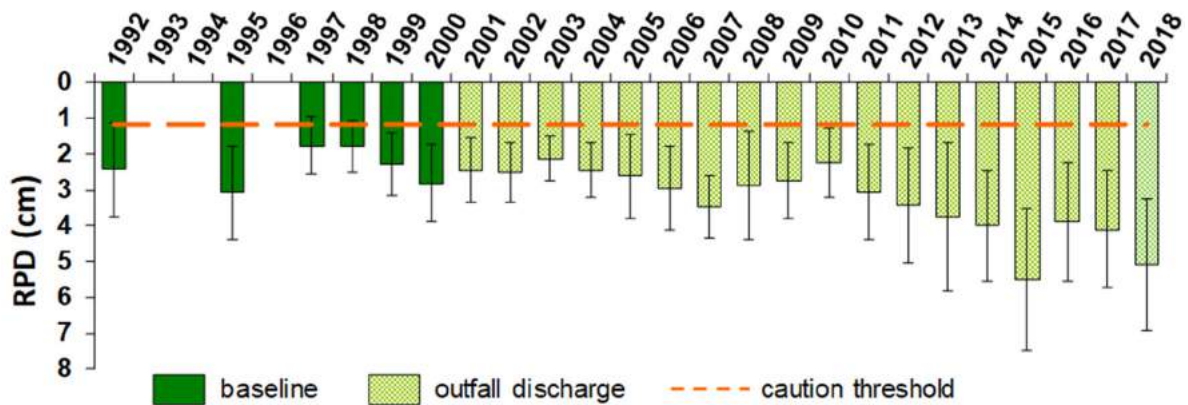
**Figure 4-8. Annual apparent color RPD depth for nearfield stations.** The mean RPD has been deeper than in baseline years, a strong indication of no adverse effect from the discharge.

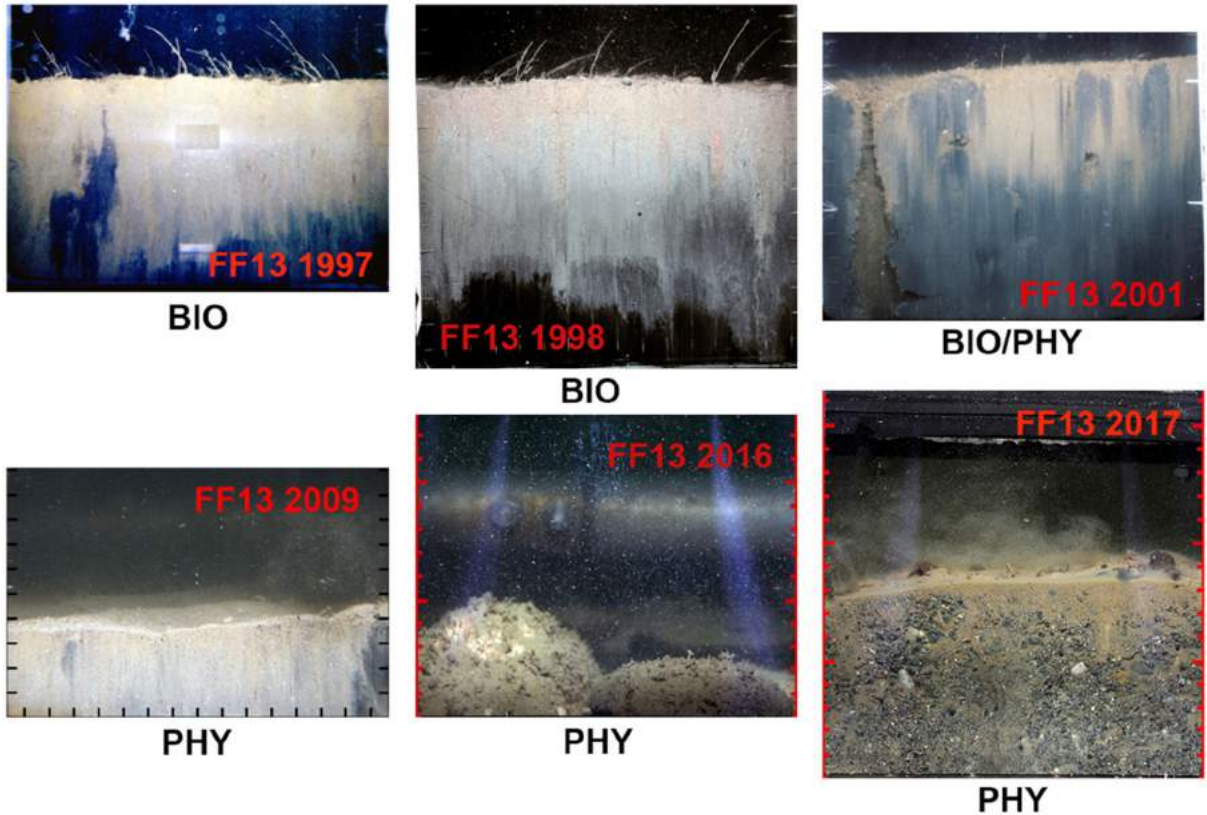
Figure 4-10. Physical and biological forces structuring sediments shown in sediment-profile images from Station FF13, southwest of the outfall, 1997–2017. BIO = biological dominance, PHY = physical dominance. Scales on sides of images are centimeters.
