2019 Outfall Monitoring Overview

Massachusetts Water
Resources Authority
Environmental Quality
Department Report 2020-11

November 9, 2020

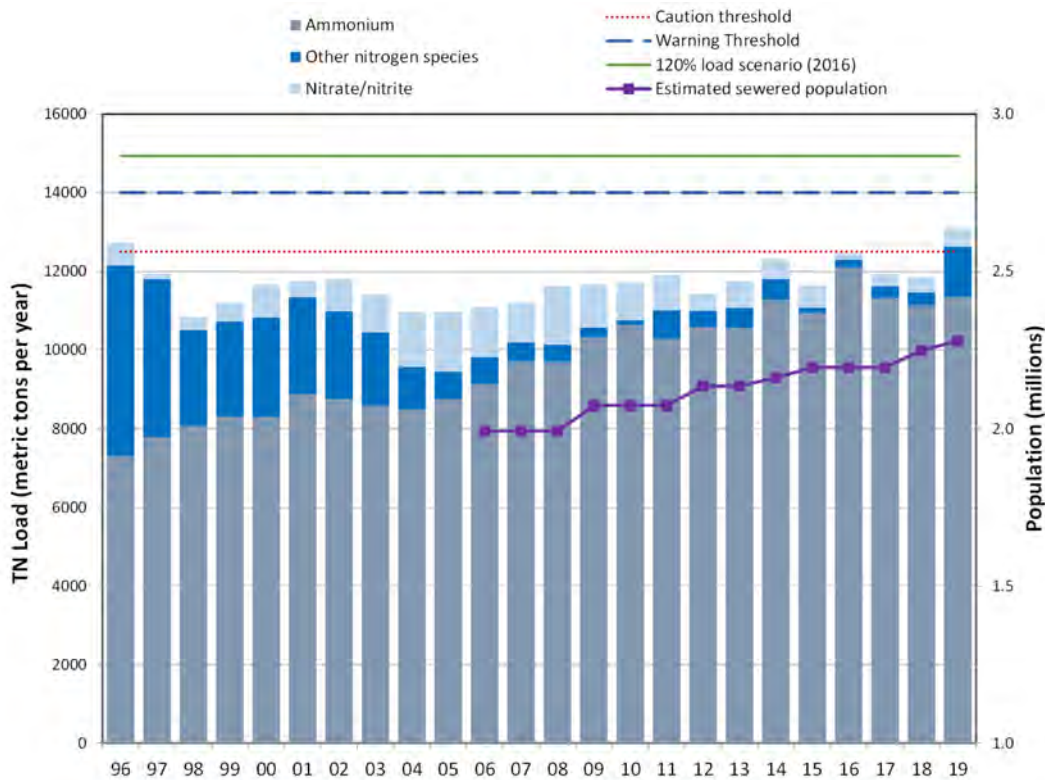
Figure ii. Annual nitrogen discharges, 1996–2019, and estimated population of the MWRA service area, 2006–2019. During outfall planning, experts estimated that discharges would total 14,000 metric tons per year by 2020. The warning threshold was set at that level, and the caution level was set at about 90% of that projected load. A water-quality model simulation using 120% of the 2016 discharge (green line) projected negligible environmental effect.

Total nitrogen discharges in 2019 were 13,217 metric tons, exceeding MWRA’s Contingency Plan caution level (12,500 metric tons per year), which is set at approximately 90% of the warning level, 14,000 metric tons per year (Figure ii). The warning level had represented the anticipated nitrogen load for the year 2020, so it was not surprising that the caution level could be exceeded in 2019. In fact, nitrogen removal at Deer Island Treatment plant has been more successful than had initially been predicted, about 30% rather than 10–15%. Total nitrogen discharges track well with population growth in the MWRA service area. Population growth has been about 8% since 2010, while increases in nitrogen discharges have been about 7%.

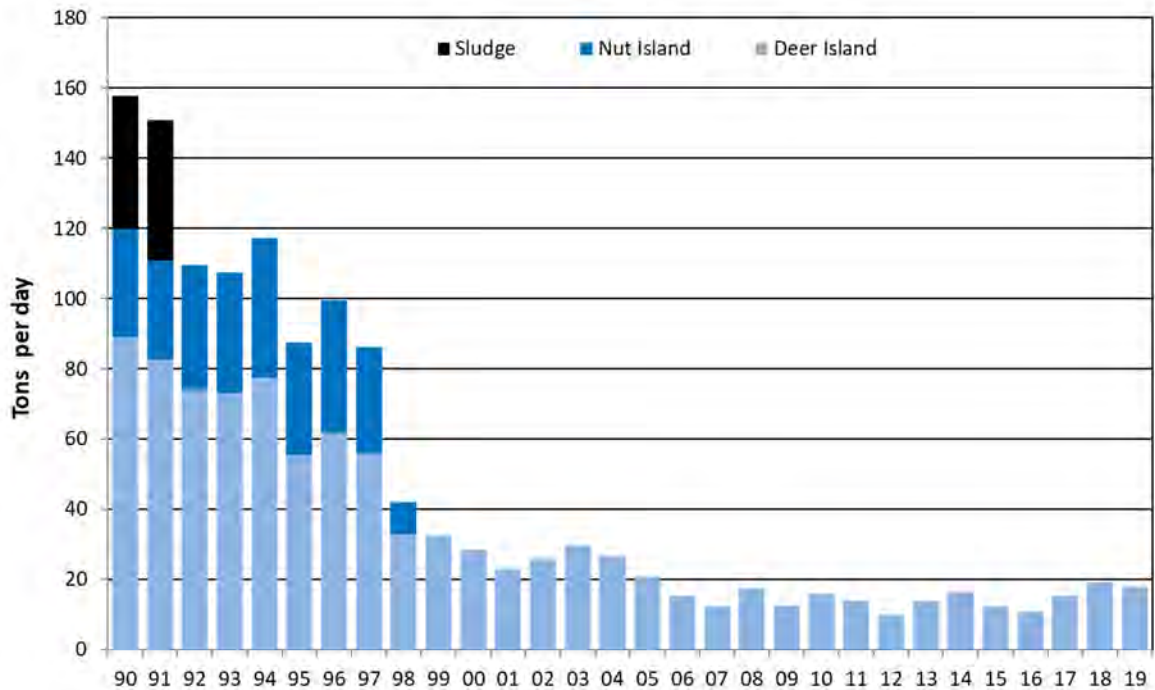
Figure 2-4. Annual solids discharges, 1990–2019. Before December 1991, biosolids (sludge) removed during treatment were disinfected and discharged into Boston Harbor. Ending biosolids disposal, ending effluent discharge to the southern portion of the harbor from Nut Island, implementing secondary treatment, and ending all discharges to the harbor in September 2000 were important steps in the Boston Harbor Project. Since 2006, variability in solids discharges to Massachusetts Bay can mostly be attributed to variation in flow.

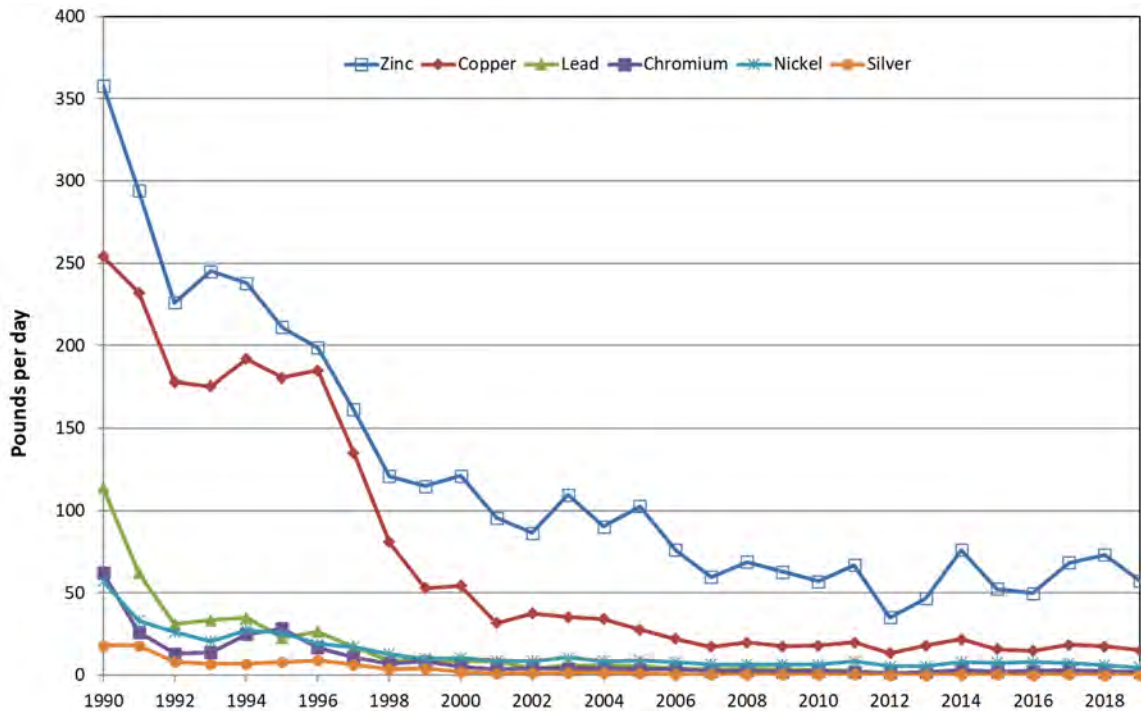
Figure 2-5. Annual metals discharges, 1990–2019.

Metals loads also remained low in 2019, with little evidence of increases associated with higher flow (Figure 2-5). Zinc continued to be the most abundant metal in the annual discharge, followed by copper. Both are present in water pipes and fixtures. Other notable sources of zinc to wastewater include commercial enterprises, such as beauty shops, automobile-repair shops, and hospitals; residential household products, such as shampoos, ointments, and laundry detergent; and street runoff (MWRA unpublished data).

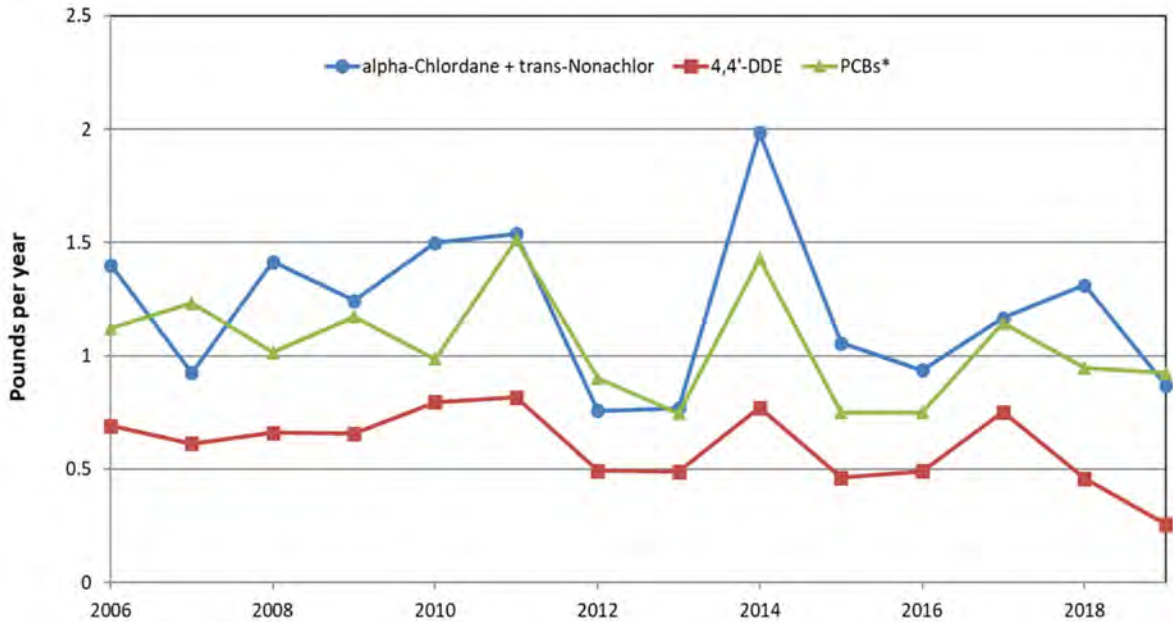
Figure 2-6. Annual discharges of organochlorine compounds, 2006–2019.

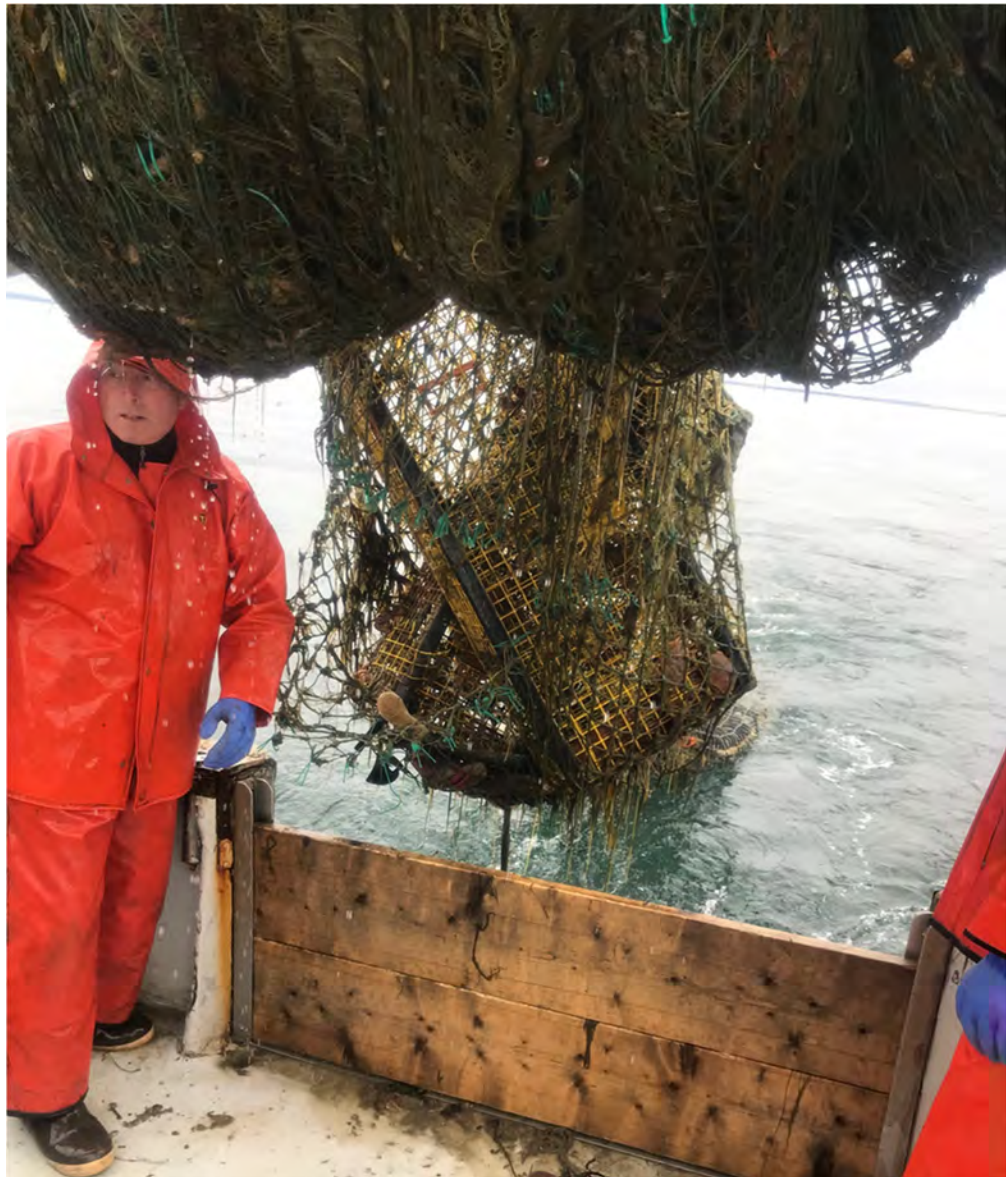
Figure 5-2. Lobster gear in flounder net trawl. Photo credit Michael Moore, Woods Hole Oceanographic Institution

Annual flounder monitoring for external condition and the presence of liver disease and tumors was hampered in April and May 2019 by a barge laying a new cable to Deer Island, weed clogging, and abandoned lobster gear, which can require cutting the flounder net (Figure 5-2). Only 40 fish were taken at Deer Island Flats and only 20 off Nantasket Beach, with the full complement, 50 fish, taken at the outfall site and eastern Cape Cod Bay.

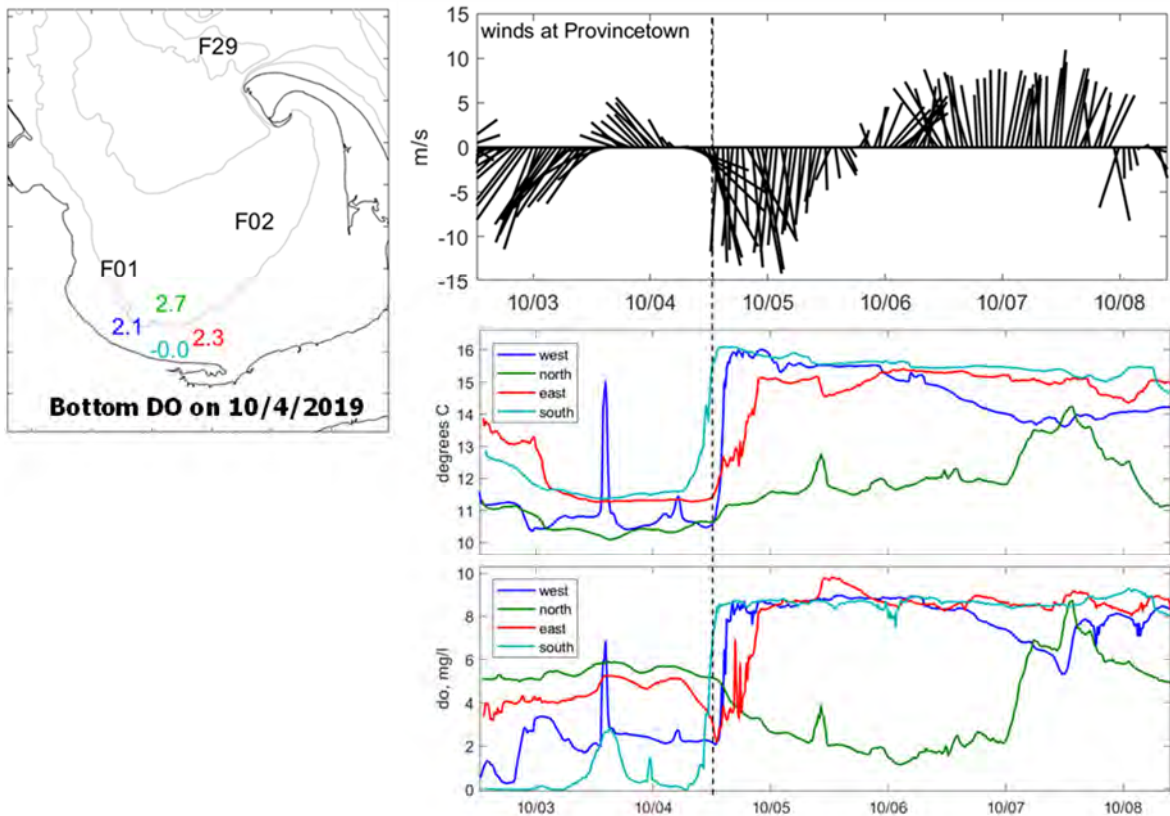
Figure 6-5. The hypoxia and anoxia dissolved oxygen event in southern Cape Cod Bay, 2019. (Top left) Map showing MWRA stations in black and bottom dissolved oxygen concentrations at the Department of Marine Fisheries hypoxic/anoxic site sensors on October 4; (Top right) Wind direction and intensity at Provincetown, showing strong winds from the north on October 5; (Middle) Bottom temperature at the site sensors; (Bottom) Bottom-water dissolved oxygen concentrations at the site sensors. Color coding of the lines matches site locations on the station map. DO = dissolved oxygen
