2022 Outfall Monitoring Overview

Massachusetts Water
Resources Authority
Environmental Quality
Department Report 2023-09

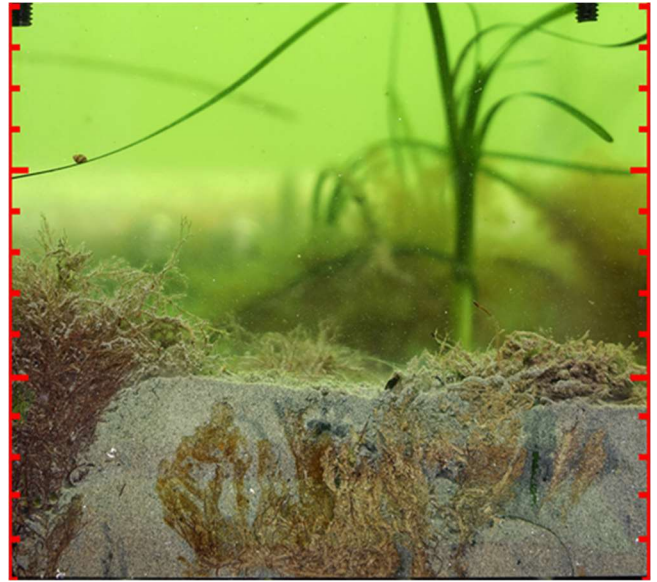
Figure vi. An eelgrass bed continues to thrive near the former outfall location near Deer Island. This sediment-profile image taken at Station R08 (red dot on the map) shows healthy eelgrass, well oxygenated sediment, and excellent water clarity.

While monitoring in Massachusetts Bay has shown that the outfall does not degrade the environment, Boston Harbor continues to improve since the effluent discharge was diverted from the harbor to the bay. Boston Harbor monitoring stations that had been subject to effluent discharge before September 2000 now exhibit healthy habitats, including thriving eelgrass, a sign of good seafloor conditions (Figure vi).

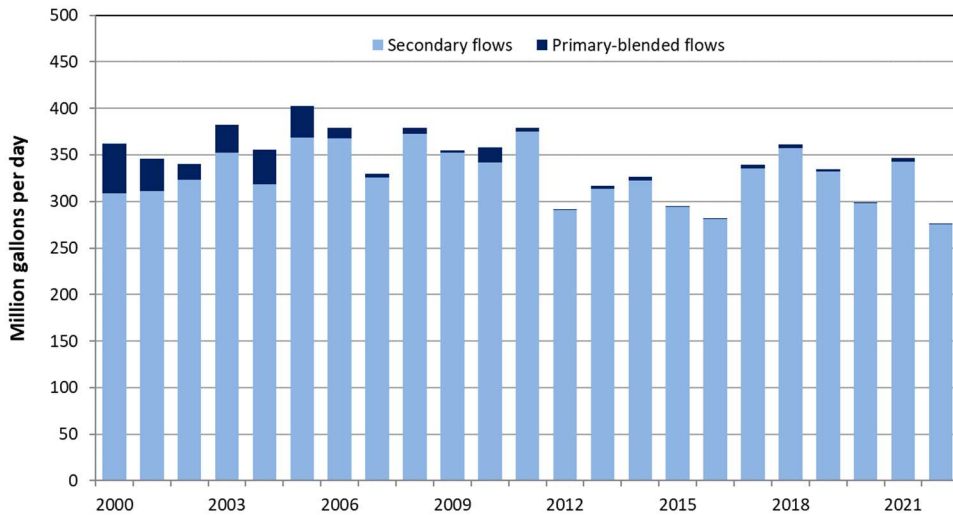
Figure 2-2. Annual full secondary-treated effluent flows and primary-blended flows, 2000–2022. During large storms, flow exceeding the secondary capacity of the plant is diverted around the secondary process; this primary-treated flow is blended with the fully treated flow before disinfection and discharge. Blended flows meet all permit limits.

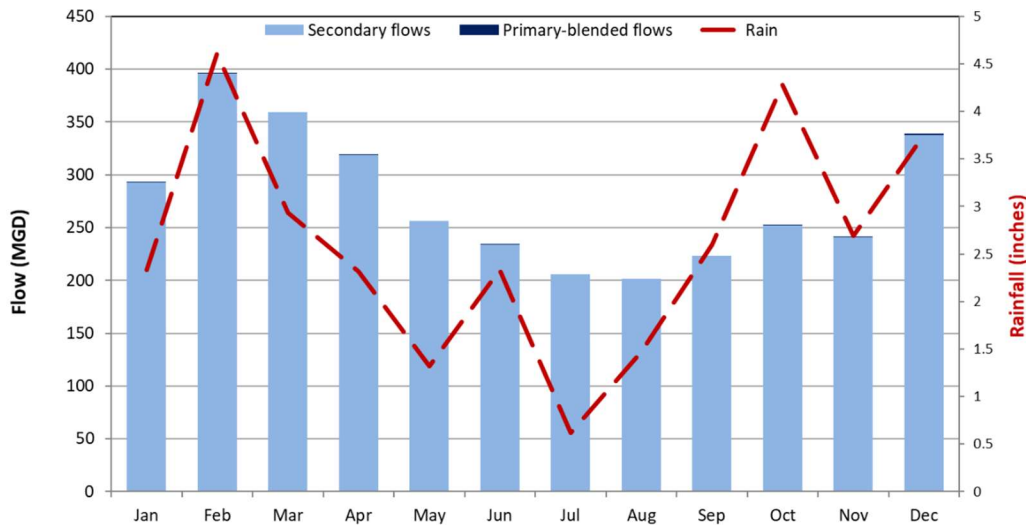
Figure 2-3. Monthly full secondary-treated and primary-blended flows and rainfall during 2022. In 2022, more than 99% of total flows received complete primary and secondary treatment.

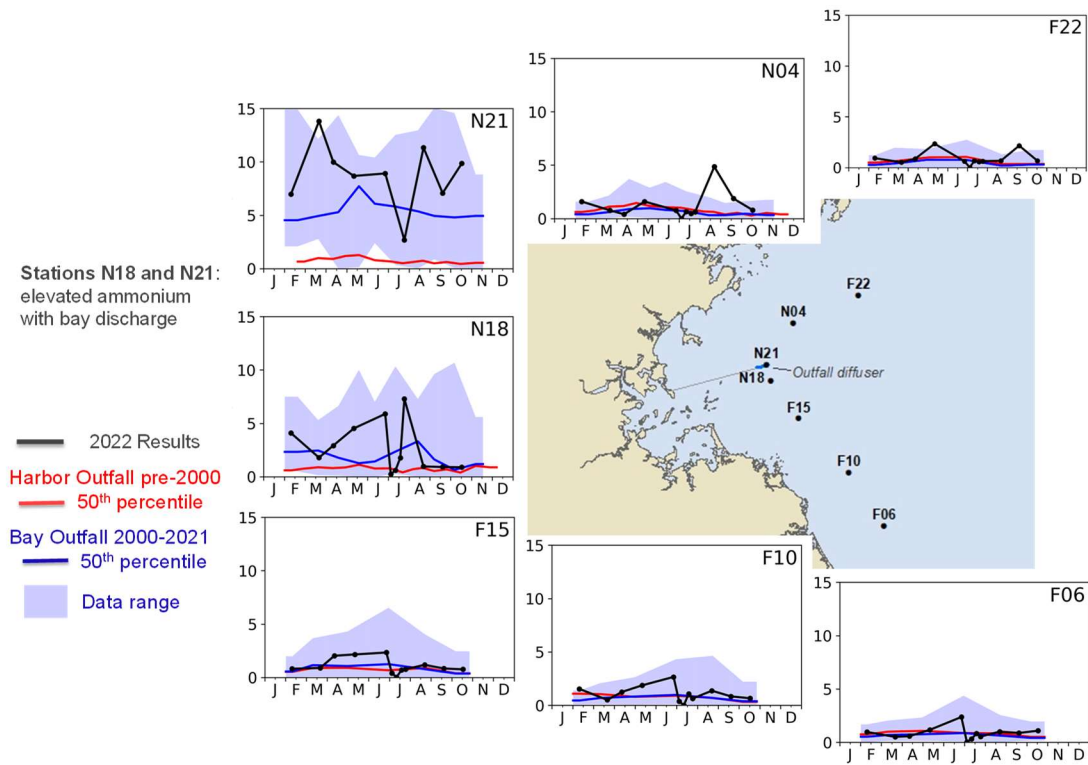
Figure 3-4. Ammonium concentrations (μM) at selected stations in 2022 compared to prior years. Increased concentrations of the sewage tracer ammonium are found at stations closest to the outfall, while stations further away have maintained concentrations similar to pre-outfall levels. The “data range” spans all measurements.

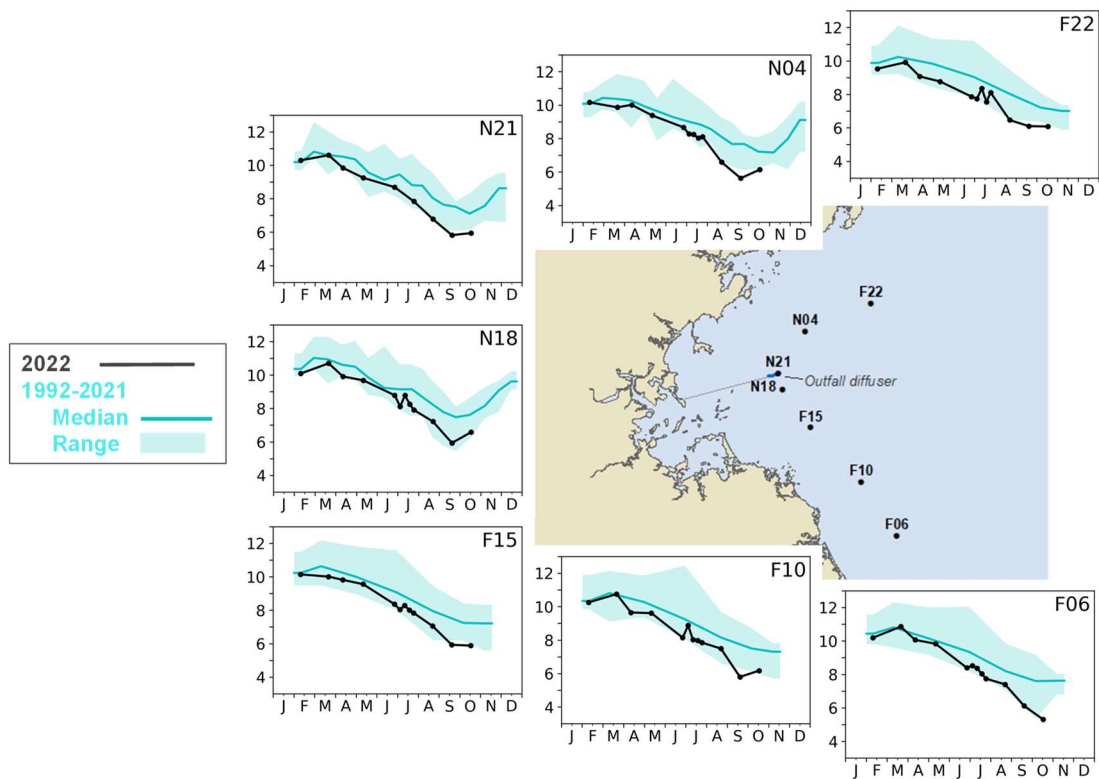
Figure 3-9. Near-bottom water dissolved oxygen concentrations (milligrams per liter) in 2022 compared to prior years. For some stations, historic data (shaded ranges) extend later in the year than the current survey schedule.

Dissolved oxygen concentrations in Massachusetts Bay bottom water declined steadily from March through the end of the survey season, with some rebounds during the notable July upwelling event, which temporarily disrupted stratification (Figure 3-9). The steady decline spanned the monitoring area, reaching the lowest levels observed by the monitoring program at some stations, and also detected at the NERACOOS Buoy A01. Percent oxygen saturation, a measure of how much oxygen is dissolved in the water compared to how much oxygen the water could hold at a given temperature and salinity, also reached low levels throughout the region. Low concentrations and percent saturation resulted in Contingency Plan caution and warning threshold exceedances in the nearfield and in Stellwagen Basin. These exceedances are discussed on page 29.

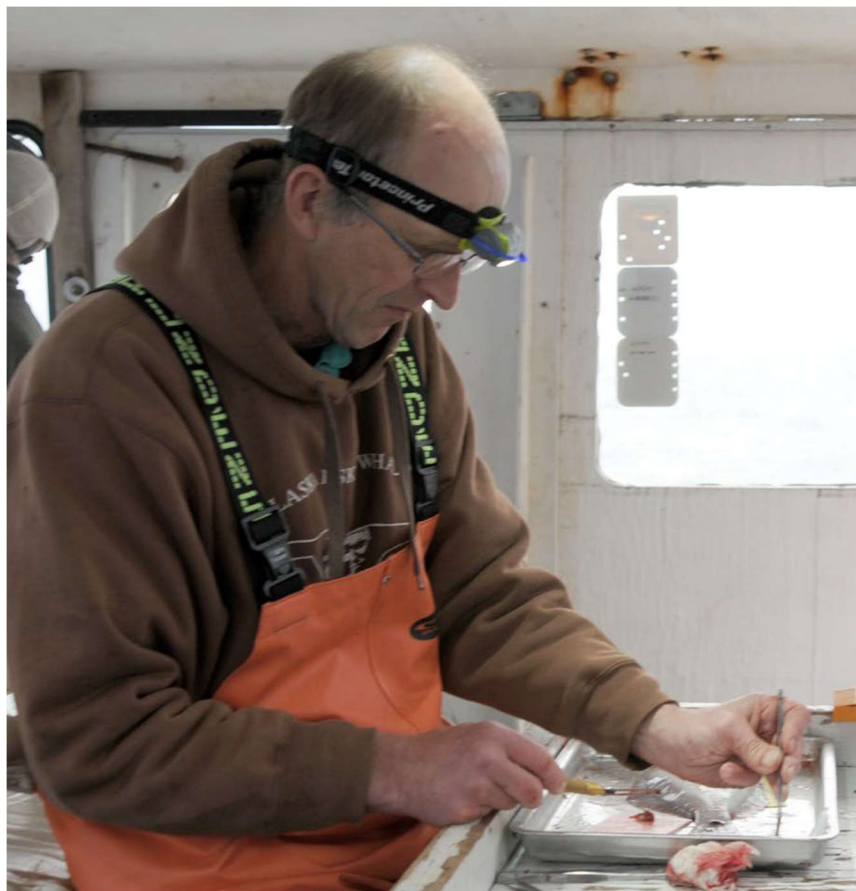
Figure 5-2. External assessments are made at sea, and livers are removed for laboratory analysis. Photo credit Eric Rydbeck, Normandeau Associates, Bedford, New Hampshire.

All sampling was completed on one day in April 2022. As in past years, scientists completed external health assessments at sea and preserved livers for laboratory analysis (Moore et al. 2023; Figure 5-2).

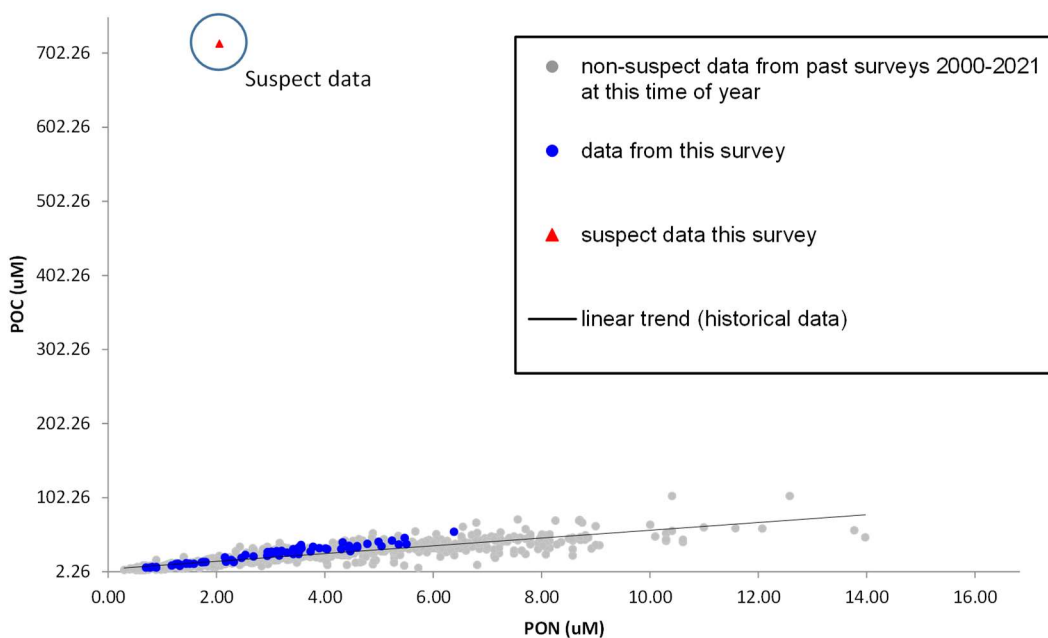
Figure 6-2. Example of a presentation used to identify suspicious data. This plot depicts particulate organic carbon (POC) and particulate organic nitrogen (PON) at one station compared to historic data. The suspect data point is flagged for review.
