**2007 outfall monitoring overview
RESULTS**

Massachusetts Water Resources Authority

Environmental Quality Department
Report 2008-17

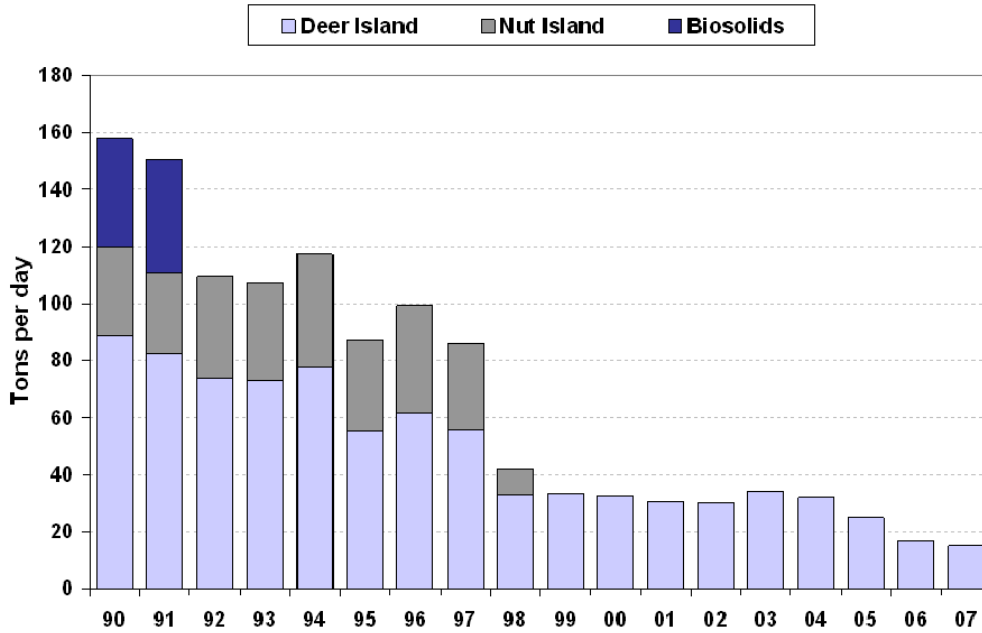
Solids in MWRA Treatment Plant Discharges 1990-2007

Figure 2-3. Annual solids discharges. Solids discharges reached a record low in 2007.

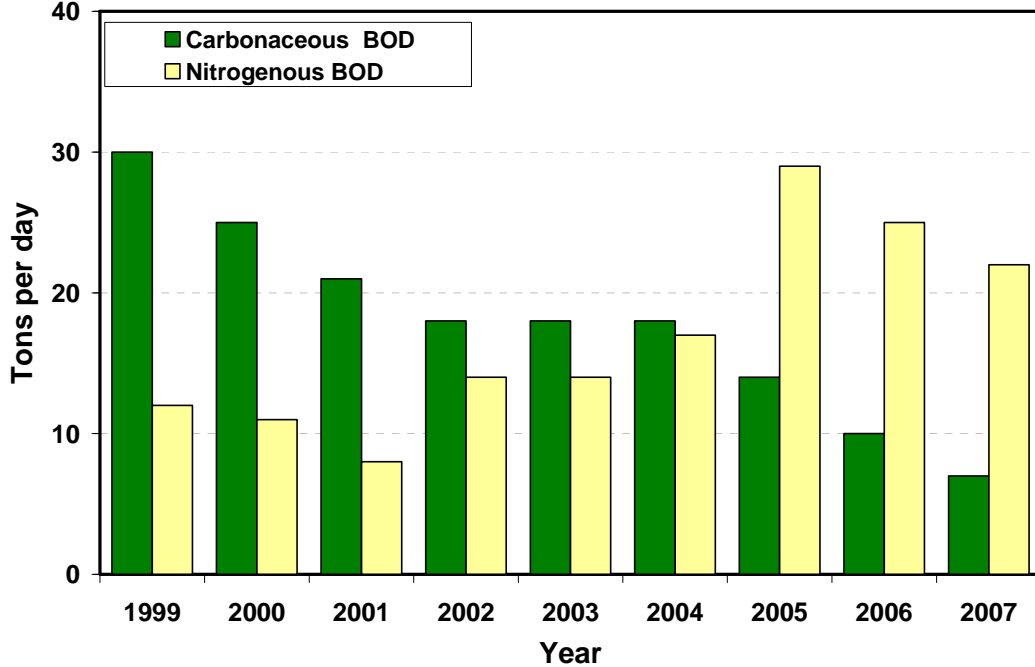
Biochemical Oxygen Demand in MWRA Discharges 1999-2007

Figure 2-4. Average biochemical oxygen demand in tons/day for the past nine years. MWRA's permit limits carbonaceous BOD, which reached a record low in 2007. Nitrogenous BOD is the result of microbiological breakdown that occurs during secondary treatment. Ambient monitoring data show that the discharge has had no effect on dissolved oxygen in the environment.

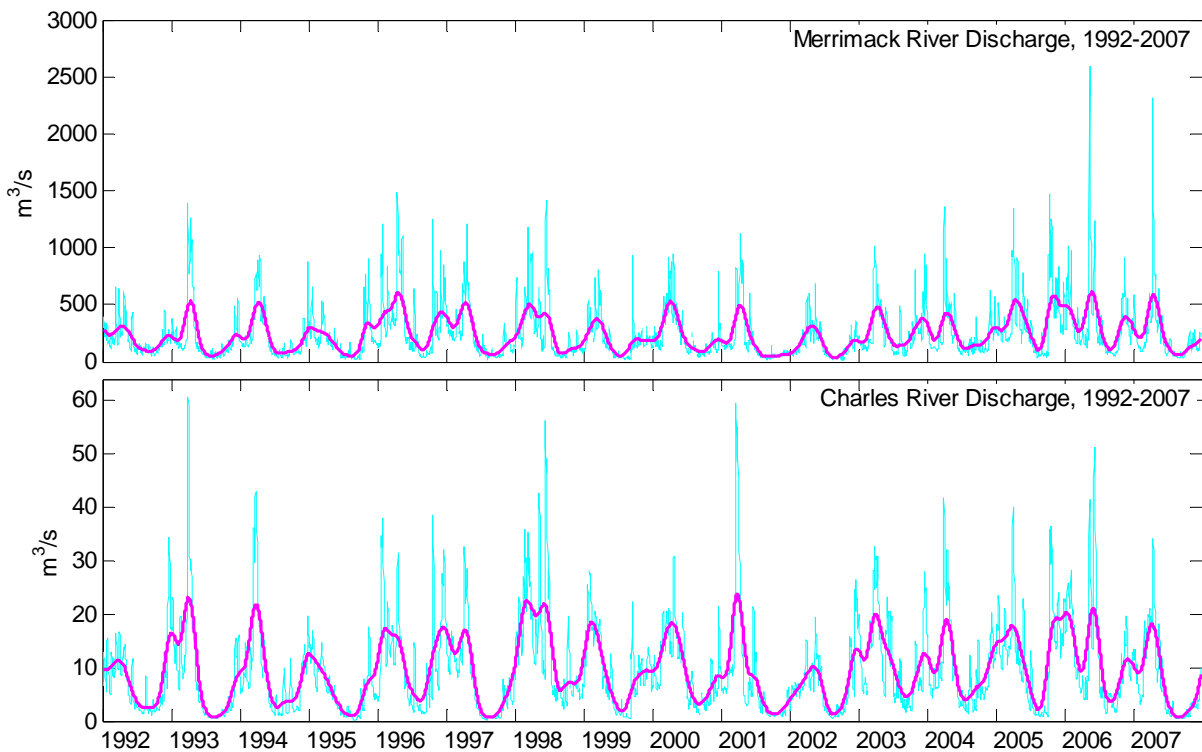
Figure 3-1. Merrimack River (top) and Charles River (bottom) discharges to the ocean. (Data are from gauges at Lowell and Waltham, Massachusetts; smooth lines are 3-month moving averages; note the differences in scale.)

Baseline and post-diversion monitoring have found that the water column in the vicinity of the outfall and throughout Massachusetts and Cape Cod bays is heavily influenced by river inflows, weather, and other physical factors. In 2007, the overall physical, water quality, and biological conditions were about average for the monitoring period and followed typical seasonal patterns. Total annual flows from the Merrimack and Charles rivers were lower than average, but flows during April through June were relatively high (Figures 3-1, 3-2). From July through the end of the year, the flows were relatively low.

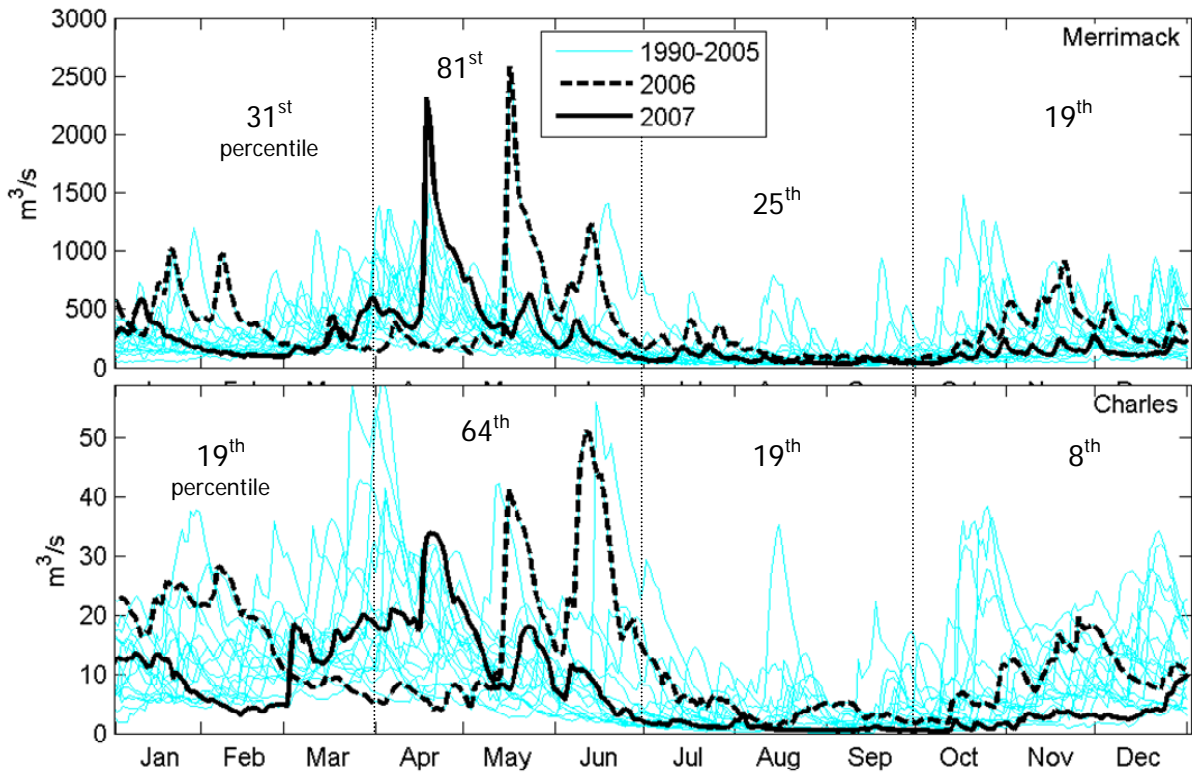
Figure 3-2. Flows of the Merrimack (top) and Charles (bottom) rivers during 2007 were relatively high in the spring quarter and low during other seasons. For example, the average April–June 2007 flow of the Merrimack River ranked 15th out of 18 years of data, which translates to the 81st percentile. The year 2006, shown for contrast, had high flow in every season.

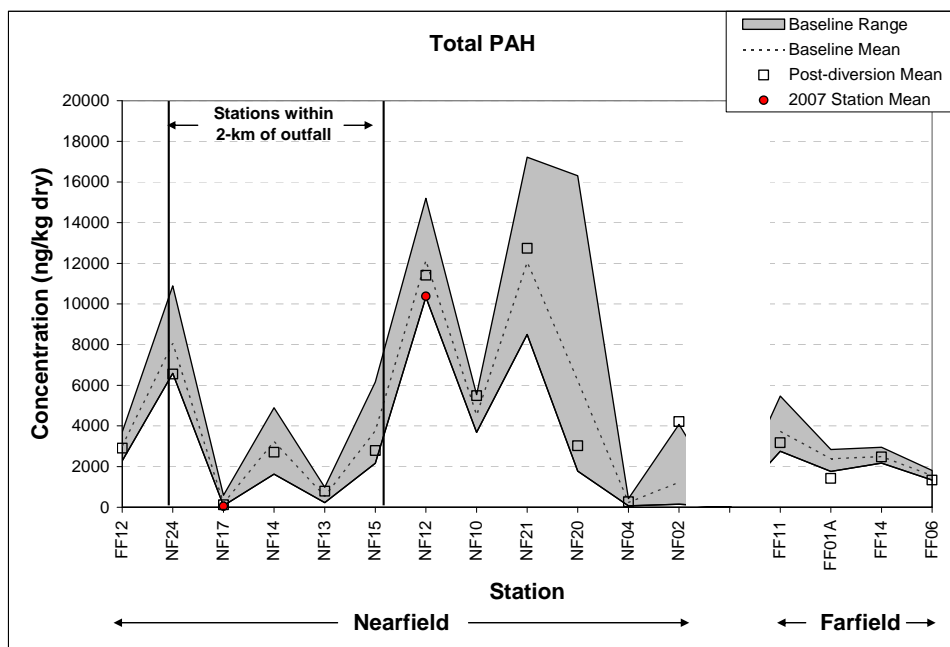
Figure 4-3. Total PAH concentrations, 1992–2007: baseline range, baseline mean, post-diversion mean, and 2007 station means. Concentrations at the two stations (NF17 and NF12) sampled in 2007 were at the low end of the baseline range, continuing to show no elevation in response to the outfall.

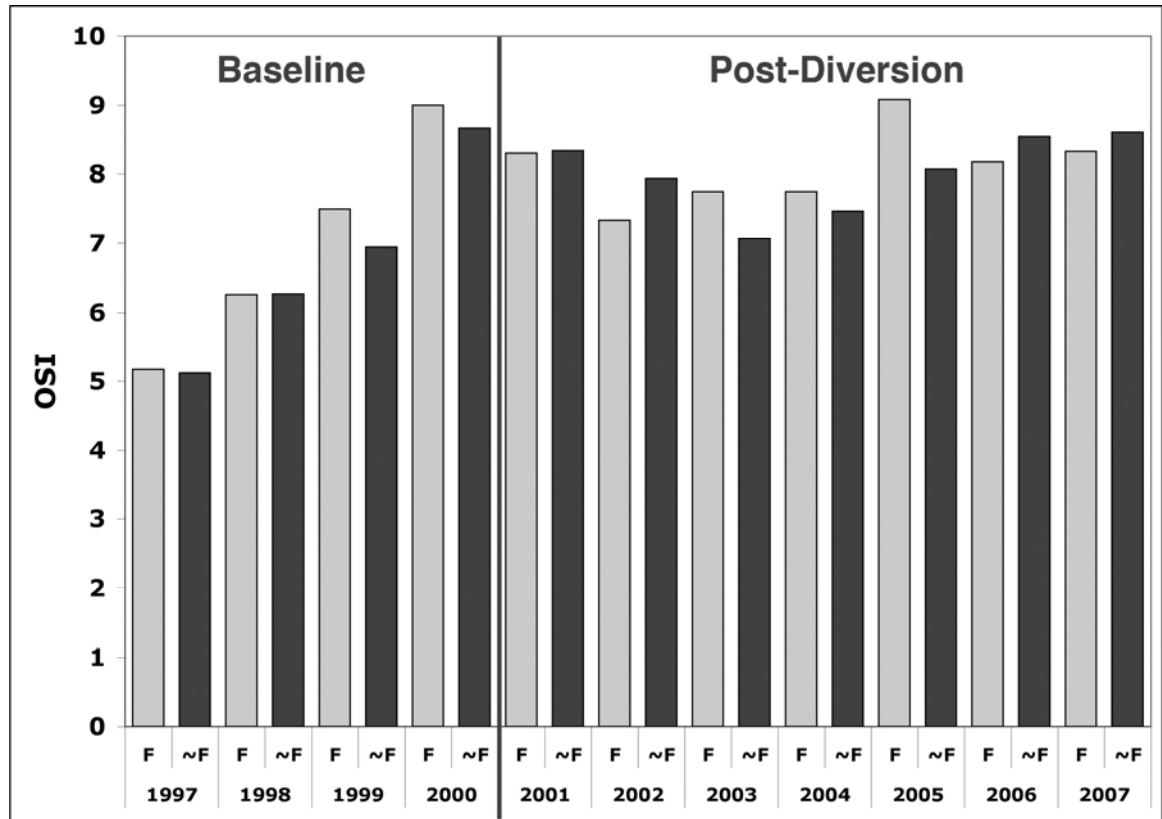
Figure 4-5. Average organism sediment index (OSI) in the nearfield by year. There has been no evidence of stress on the soft-bottom community during the post-diversion period. (F=relatively flat topographic areas; ~F=other areas; an OSI value of less than 6 can be considered to indicate stress.)

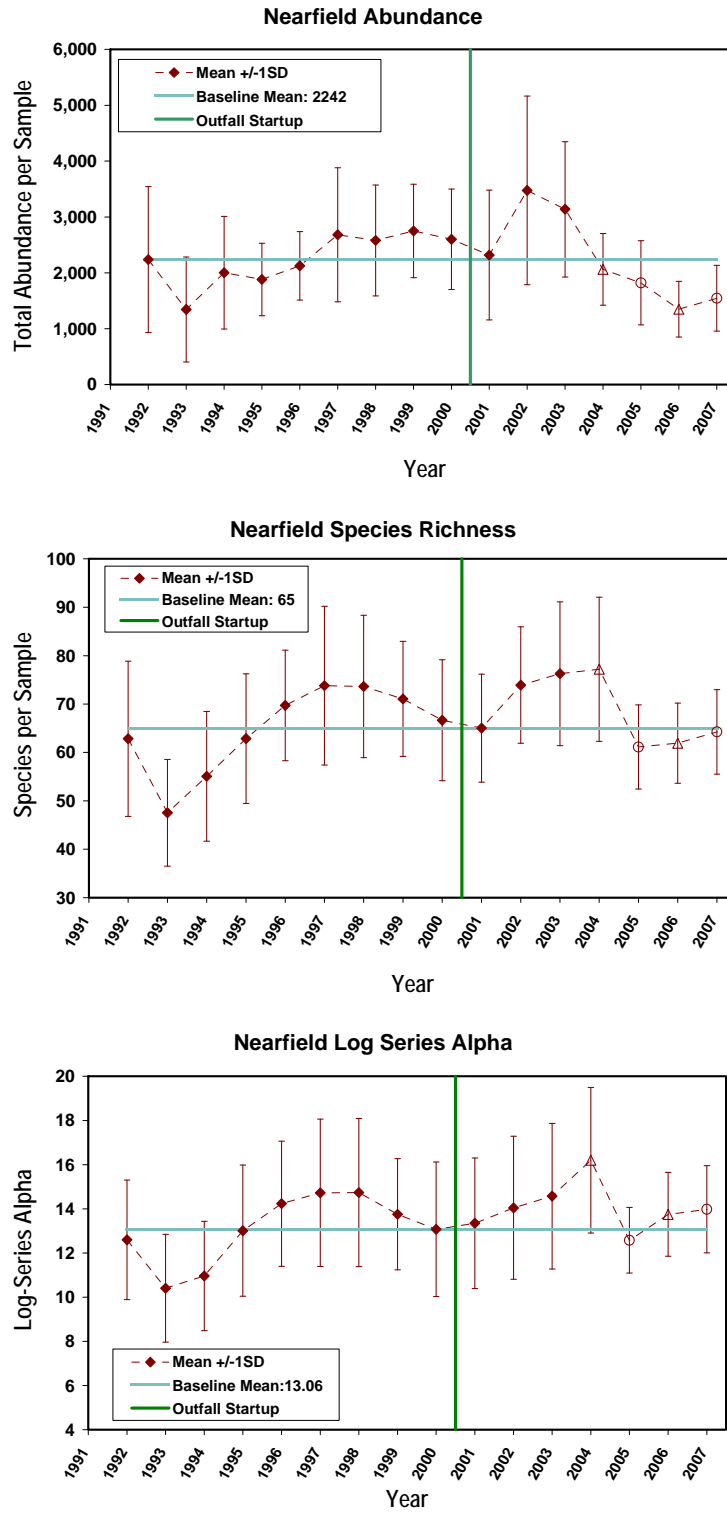
Figure 4-7. Annual community parameters in the nearfield. (Open symbols indicate modified alternate-year sampling design, 2004–2007.)

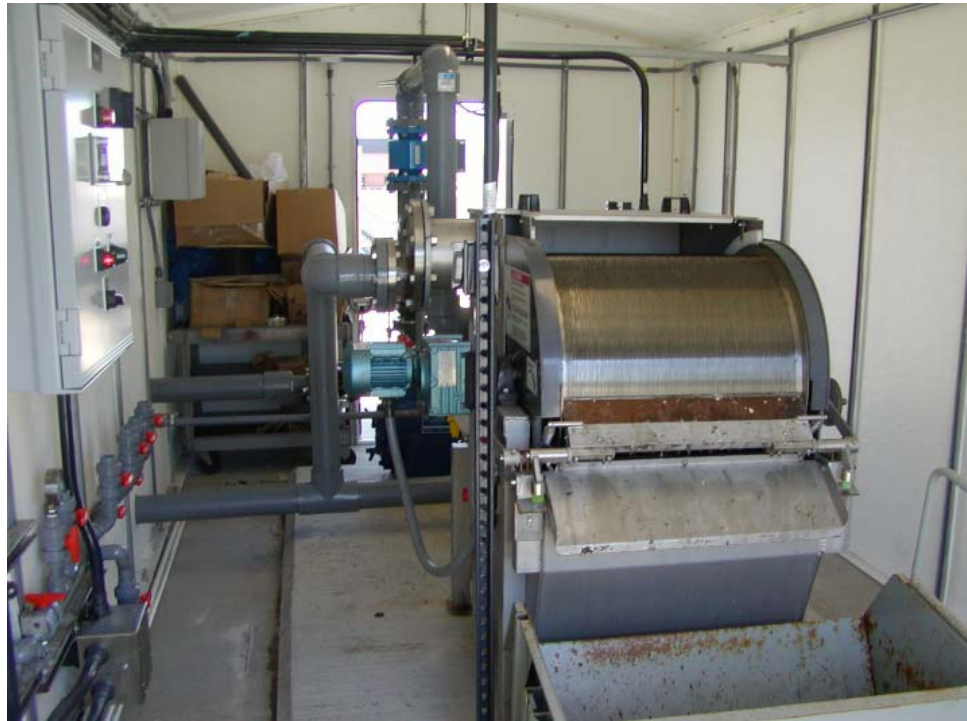
Figure 6-1. Effluent floatables sampler at the Deer Island Treatment Plant.

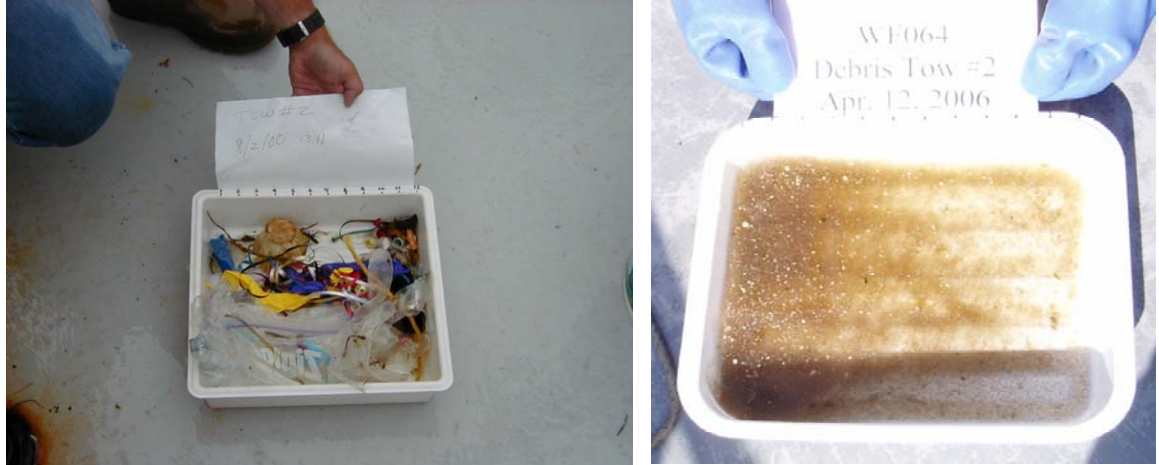
Figure 6-4. *Samples of marine debris tows at the outfall site. On the left, a sample collected before the outfall went on-line has plastic marine debris. The picture on the right, collected after the outfall went on-line, shows the fat particles which are sometimes seen.*

Debris tows (Figures 6-3 and 6-4) at both the outfall site and at a control site north of the outfall, conducted during 2000–February 2008, found plastics and paper that are characteristic of trash discarded from land or boats. Plastic was found in 33% of tows at the outfall site and 24% of tows at the control site; paper was found in 8% of tows at the outfall site and 6% of tows at the control site. No paper or plastic debris characteristic of sewage was found at either site. Although at both sampling sites, the frequency of observations of paper debris decreased in

the post-diversion (“after outfall”) period, and observations of plastic increased, these apparent differences could result from the relatively small number of samples collected before the outfall went on-line. However, small fat particles were observed in 37% of tows at the outfall site and 5% of tows at the control site. These particles are similar to the particles observed in effluent samples at the treatment plant and presumably come from the outfall. The prevalence of observations of fat particles in the outfall tows from 2004 onward was substantially higher than 2000–2003, but it is likely that this finding is due to improvements in the field crews’ awareness of and ability to see them in the tow samples. Such particles are only rarely directly observed in the environment; they must be concentrated in the net tows to be seen and do not have a significant aesthetic impact.

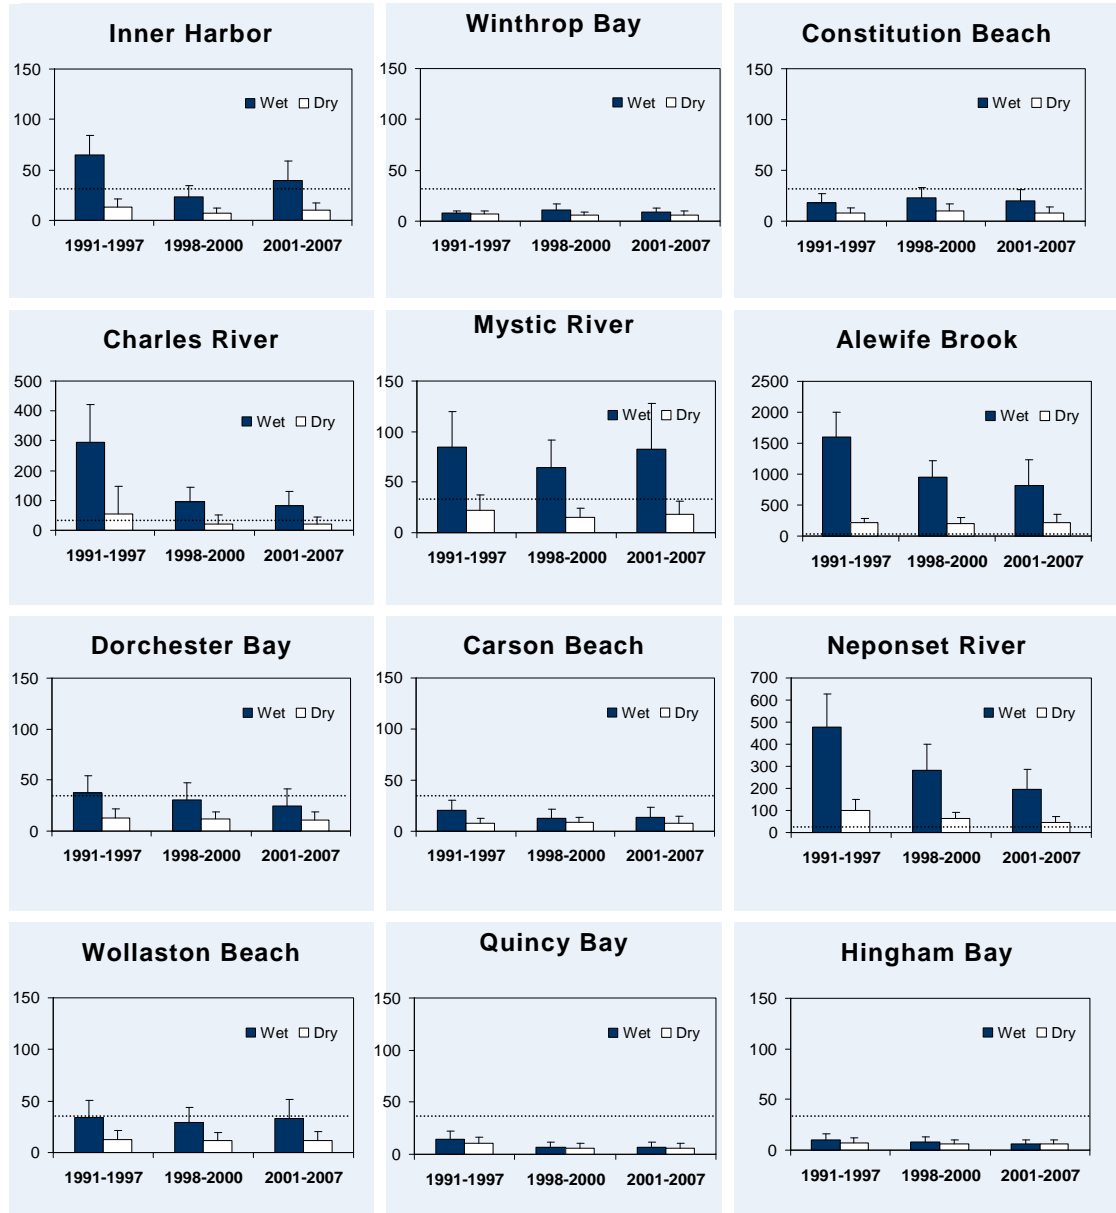
Figure 6-10. Changes in Enterococcus counts during wet and dry weather, 1991–2007 in 12 areas of Boston Harbor and its tributaries. Wet = Rain > 2 inches of the previous 2 days. Dry = No rain over the previous 3 days. Dotted lines show the standard, 35 colonies/100 ml.
